**RE: Hearing Order OH-001-2014**  
**Trans Mountain Pipeline ULC (Trans Mountain)**  
**Application for the Trans Mountain Expansion Project (Project)**  
**Elizabeth May Written Evidence**

# The Behaviour and Environmental Impacts of Crude Oil Released into Aqueous Environments

**Meeting of the Royal Society of Canada's Expert Panel on  
*The Behaviour and Environmental Impacts of Crude Oil Released into Aqueous Environments*  
Wednesday, February 4, 2015**

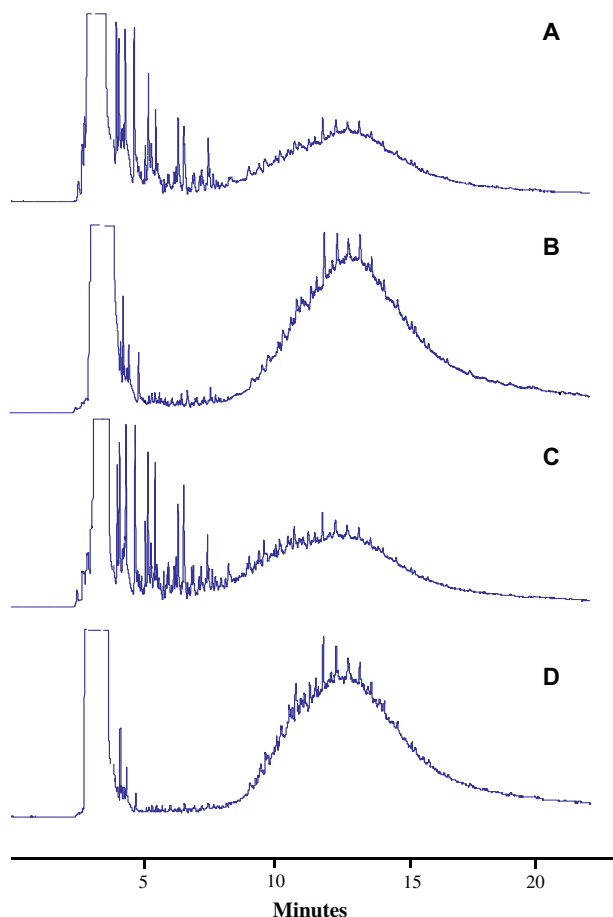
Fig. 1. GC-FID chromatograms of naturally weathered dilbit products (A) AWB at 1 h, (B) AWB at 13 days, (C) CLB at 1 h and (D) CLB at 13 days.

Fig. 1 (scales for all four plots are the same) illustrates chemical profiles of the oils generated by GC-FID. For both products, a large

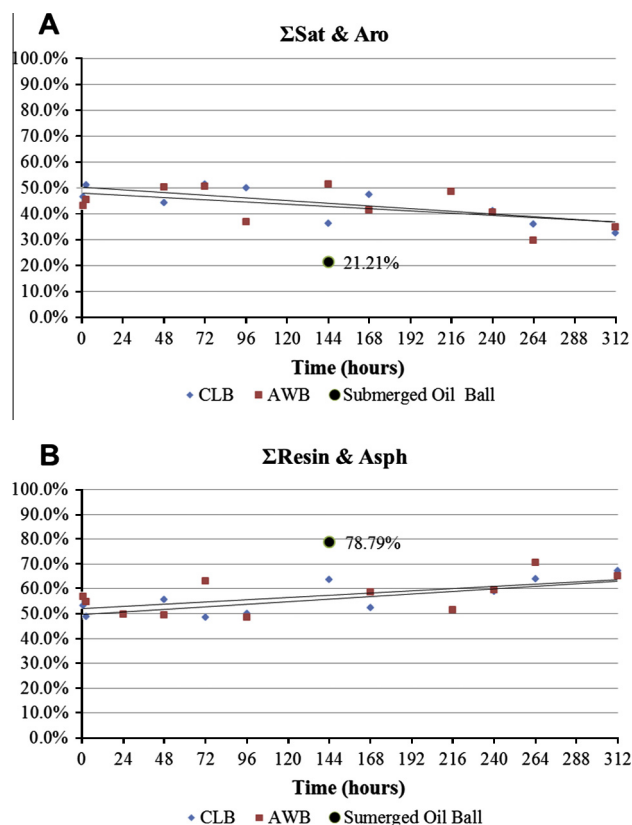
Fig. 2. TLC-FID data: (A) saturates and aromatics and (B) resin and asphaltenes in oil subsamples collected at various time points during the natural weathering of dilbit products.

A full suite of subsamples, collected at various time points, were examined using TLC-FID. Fig. 2 shows that there is a decreasing trend (ANOVA;  $p$ -value < 0.05) of saturates and aromatics (low molecular weight compounds) with time. Conversely, an increasing trend of the relative mass of the resins and asphaltenes (high molecular weight compounds) was observed as function of time (ANOVA;  $p$ -value < 0.05). Due to the high variability in the data, no functional form beside the trend should be inferred, and the linear behavior reported in the graphs was selected simply because it makes the least amount of assumptions. Nearing the end of the study, the oil composition contained a greater percentage of high molecular weight hydrocarbons. At six days of natural weathering, submerged oil-balls were visible in the seawater column (Fig. 3) and their presence was correlated with the lower salinity, (17 p.s.u.) in the upper 10 cm of the water column that resulted from the influx of rainwater, on day 5. The salinity below the 10 cm depth was 27 p.s.u. Submerged oil-balls continued to accumulate over time and they were collected only at the end of the experiment (312 h). The submerged oil-balls were related to changes in oil density and seawater salinity.

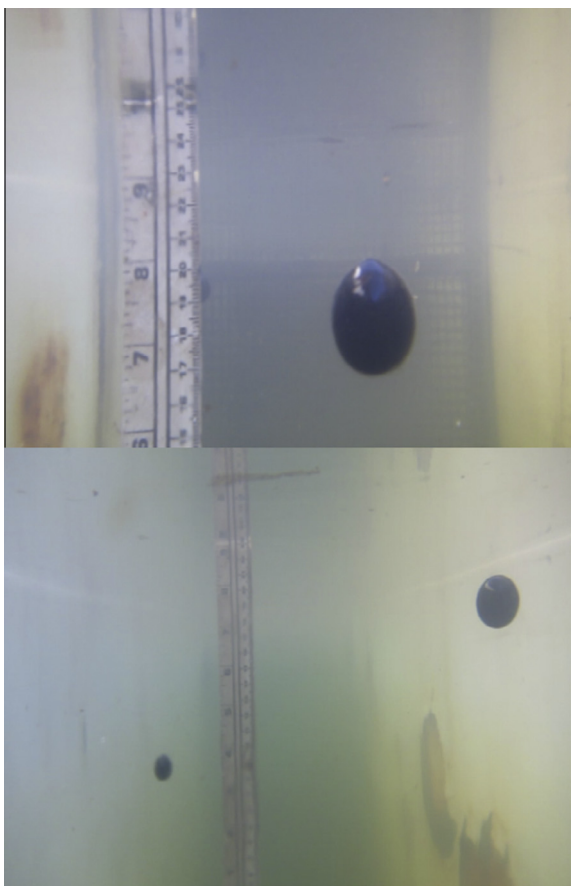
**Fig. 3.** Photos of submerged tar balls during the natural weathering of diluted bitumen products. Tar-balls are found at ~10 cm below the seawater surface.

The chemical composition of the submerged oil-balls differed from the oil collected at the seawater surface (Fig. 3). The oil-balls were more weathered than the oil contained in the rings, as evidenced by the high mass portion of resins and asphaltenes in them (Fig. 3). It was difficult to estimate what percentage of submerged oil-balls represented the 15–18% of the total degraded oil. Subse-

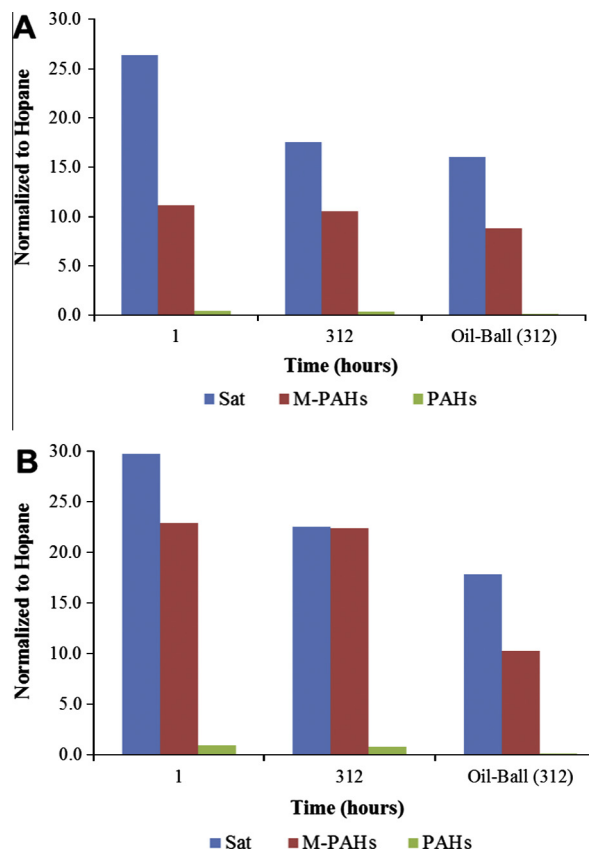
**Fig. 4.** Saturates and aromatics normalized to hopane for oil samples collected at 1 and 312 h and a tar ball: (A) AWB and (B) CLB.

quently, the samples were analysed by GC–MS (Fig. 4) to assess the long-term fate of the diluted bitumen products and the chemical composition of the submerged oil-balls. With the exception of methylated polycyclic aromatic hydrocarbons (M-PAHs), the PAHs and alkanes, detected in the oil samples, degraded pretty rapidly with time (Fig. 3). The chemical composition of the oil-balls more closely matched the chemical composition of the AWB based on the GC–MS data. It is hypothesised that the submerged oil-balls were generated from the natural weathering of AWB rather than CLB, which contains a larger fraction of M-PAHs that are more resistant to natural weathering processes. This observation is consistent with the findings of previous test tank studies with CLB, where the weathering of CLB was not sufficient to cause it to sink in fresh water even after days of exposure in an artificial environment (SL Ross, 2012).

As Fig. 5 shows, the models were able to capture closely the observed behavior of the density throughout the duration of the experiment. The model clearly illustrates that the maximum density of AWB (1.008) is much larger than that of CLB (1.0014) and that it takes less time (16 h to increase by half of the amount  $\rho_f - \rho_o$ ) for the AWB to approach its final density in comparison with CLB (24 h to increase by half of the amount  $\rho_f - \rho_o$ ). The time difference is not major when evaluating oil weathering on large time scales, but could be important when responding to an oil spill, where a difference of 12 h could result in sinking of a particular oil (AWB in this case). Density measurements could not be obtained from the oil-balls, since there was insufficient sample volume collected during sampling. However, the submergence of the oil-balls in the surrounding water is a clear indication that their density was larger than the surrounding fluid. In particular, the salinity was approximately 17 p.s.u.; with a measured water density of 1.016 kg/m<sup>3</sup> in the upper 10 cm of the seawater layer at 312 h. The AWB density results show it to be more weathered and denser compared with CLB at 312 h and these results were supported by chemical measurements (Fig. 4).

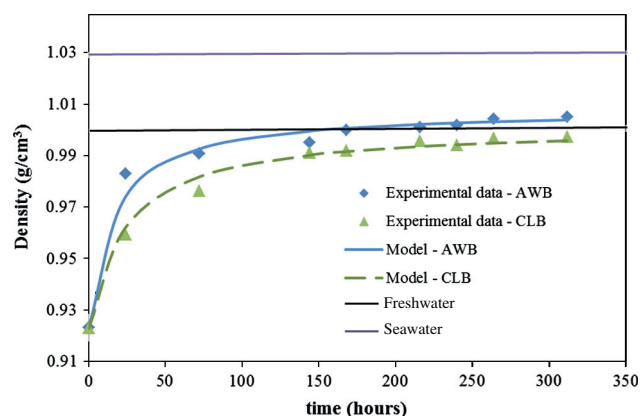
**Fig. 5.** Variations of the density of AWB and CLB as function of time. The model fits are based on Eq. (2a) and Eq. (2b) for AWB and CLB, respectively. The models were able to capture the rapid variation in the first 24 h, along with the overall trends afterwards. Brackish water fall between freshwater and seawater.

Density measurements of subsamples of the naturally weathered diluted bitumen products were plotted as a function of time in Fig. 5, which shows that the densities changed rapidly within the first 24 h and then at a slower rate after that time point. An expedient model for the density  $\rho$  behavior is given by:

ues of  $t$ , the fraction becomes equal to 1.0, and Eq. (1) reduces to  $\rho = \rho_f$ . The value of  $T$  does not affect the final value of density (i.e.,  $\rho_f$ ) rather, the rate at which the density reaches that value. For  $t = T$ , the density is the average of the final and the initial value. In other words, noting that the maximum difference in density is  $\rho_f - \rho_0$ ,  $T$  is the time it takes for the density to increase by half of this amount. By fitting to the data (Fig. 5), one obtains:

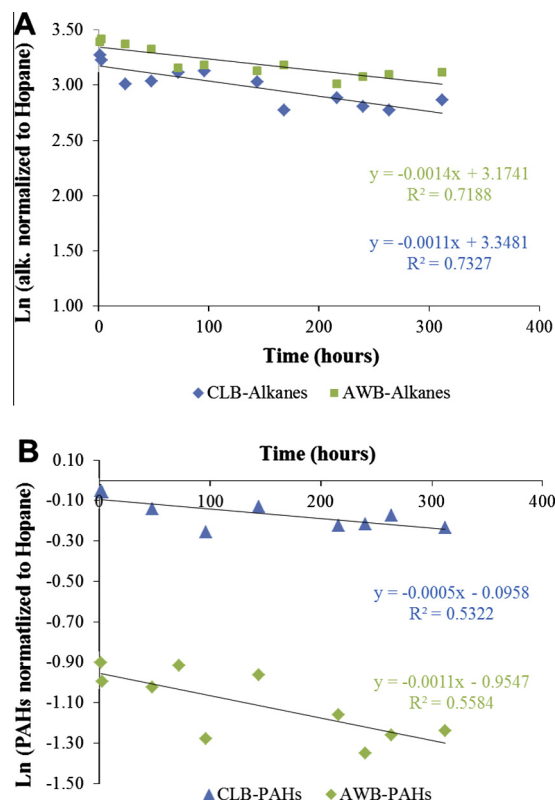
Fig. 6. 1st order rate decay plots of dilbit products (A) alkanes and (B) PAHs.

where  $\ln\left(\frac{C}{H}\right)_0$  is the y-intercept and  $-k$  is the slope of the line or the degradation rate constant and  $t$  represents time. The alkanes and PAHs followed 1st order rate decay (Fig. 6). Regression analysis showed that the 1st order rate decay curves are linear with  $p$ -values < 0.05.

The rate constant for each compound and oil was determined from the slope of the straight line. For alkanes the rate constants ( $k$ ) were 0.0011 and 0.0014 day<sup>-1</sup> for AWB and CLB, respectively. The aromatics'  $k$  values were 0.0011 and 0.0005 day<sup>-1</sup> for AWB and CLB, respectively. From the  $k$  values, one deduces that saturates in CLB degraded more rapidly than in AWB, and that the aromatics in AWB degraded more rapidly than in the CLB. The CLB contains a greater contribution of PAHs compared with CLB, including alkylated homologs which may be affecting the rate at which aromatics decay. CLB contains a higher contribution of alkanes compared with AWB, but the alkanes appear to degrade more rapidly in CLB compared with AWB. These differences may contribute to the fact that the two oils have different chemical compositions, which may affect the way natural processes that degrade hydrocarbons when dilbit is released in the aquatic environment. The degradation constants were ten folds smaller than degradation constants reported in the literature (Venosa et al., 1996). However, in those studies, the nutrient concentration was in excess of 1.0 mg-N/L, which is sufficient to produce near maximum biodegradation rates and the conventional oil was used (Boufadel et al., 1999; Du et al., 1999; Geng et al., 2013). The higher quantity of alkyl homologues of PAHs (or methylated PAHs, MPAH) and the overall persistence of aromatics associated with CLB compared with AWB, suggests that none of the CLB weathered

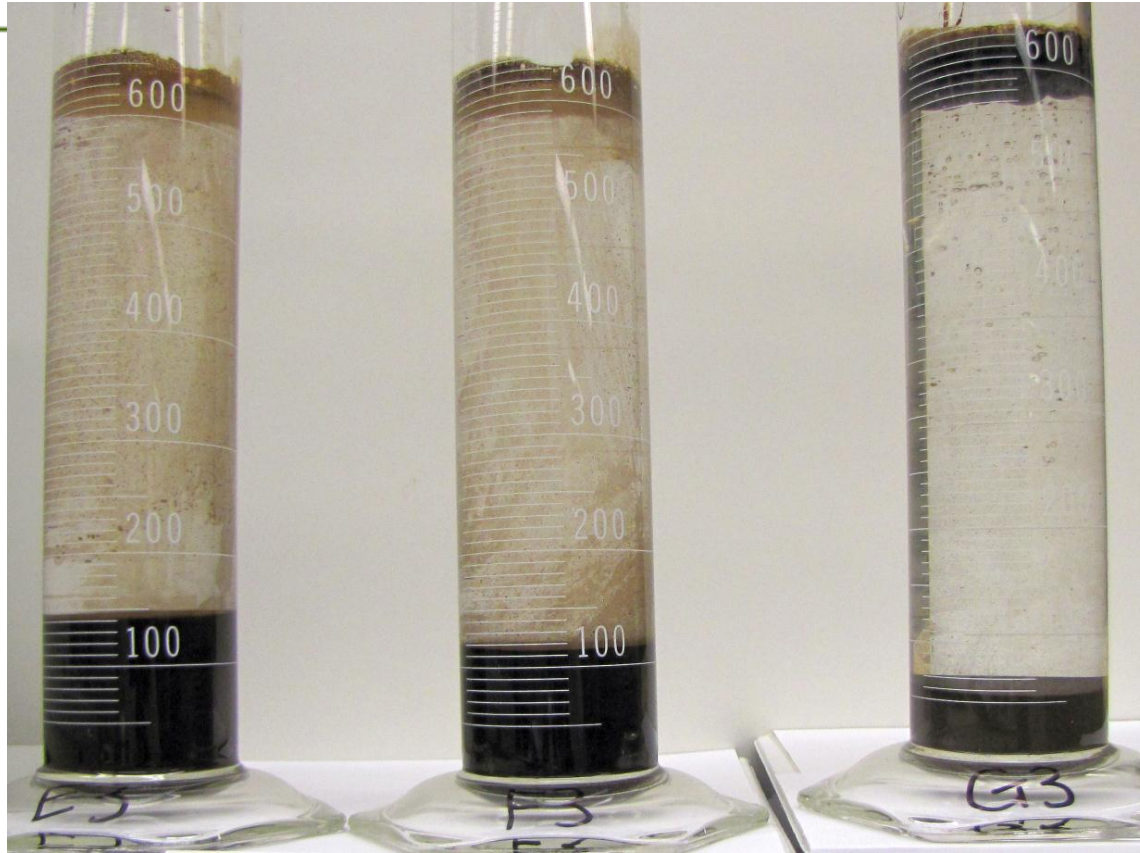
# Submerged and Sunken Dilbit

Dilbit mixed with high concentration of fine sediment for 8 hours, allowed to settle for 24 hours

(15 °C, sea water--- 3.3% salt, Access Western Blend oil)

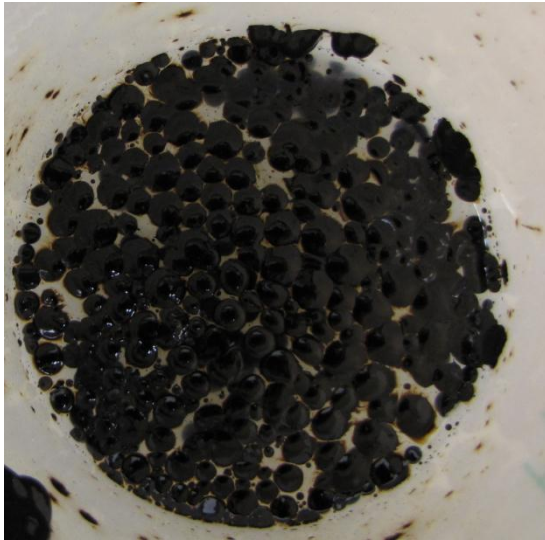
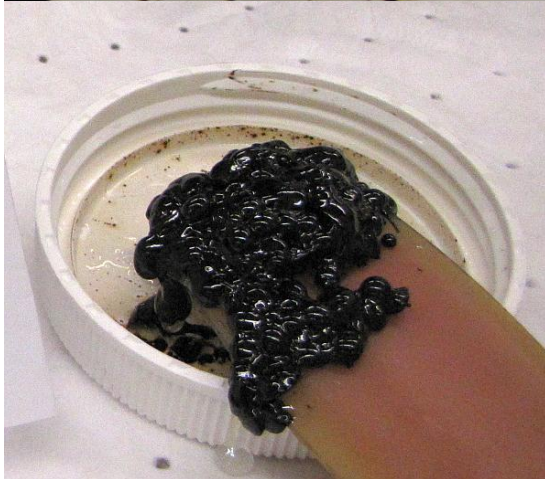
# Floating Oil “Balls”

Highly evaporated dilbit mixed with saltwater and fine sediment

Oil has very high viscosity, similar to native bitumen

Discrete oil “balls” form after mixing (fingernail size)

Floats in seawater

Photos: Access Western Blend, 25% evaporated, 8 hours at 15 °C)

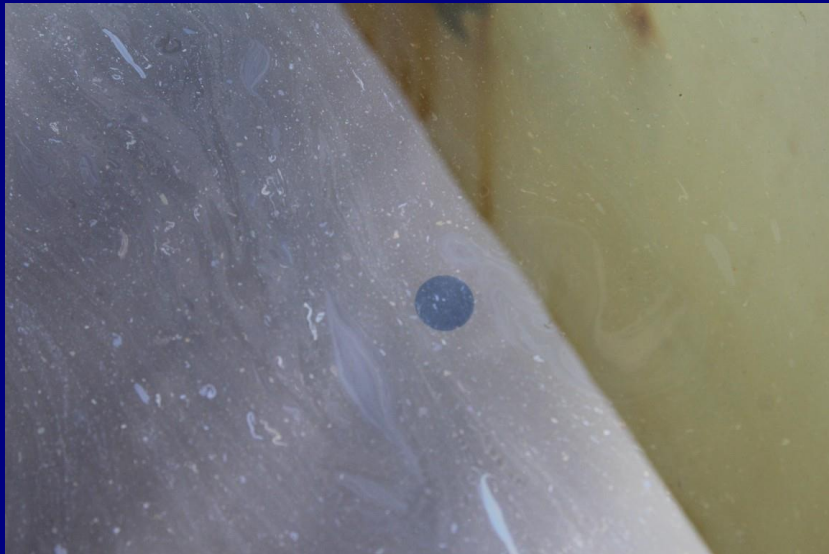
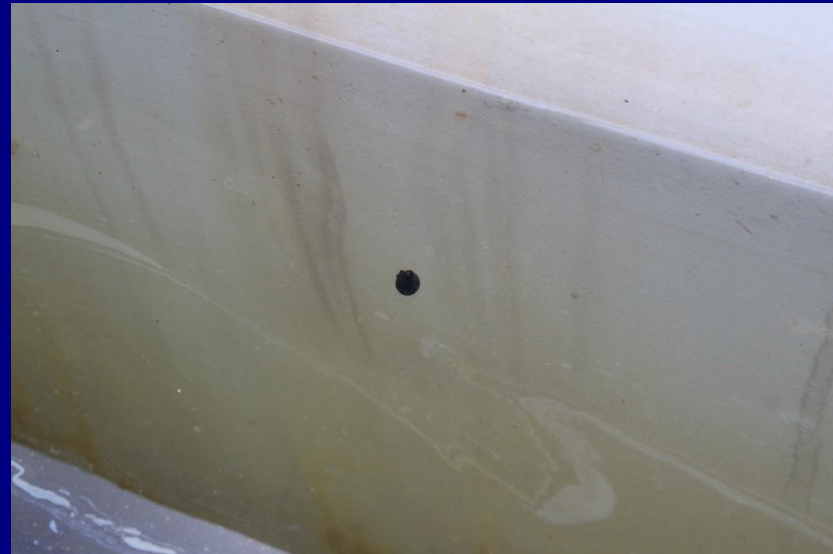
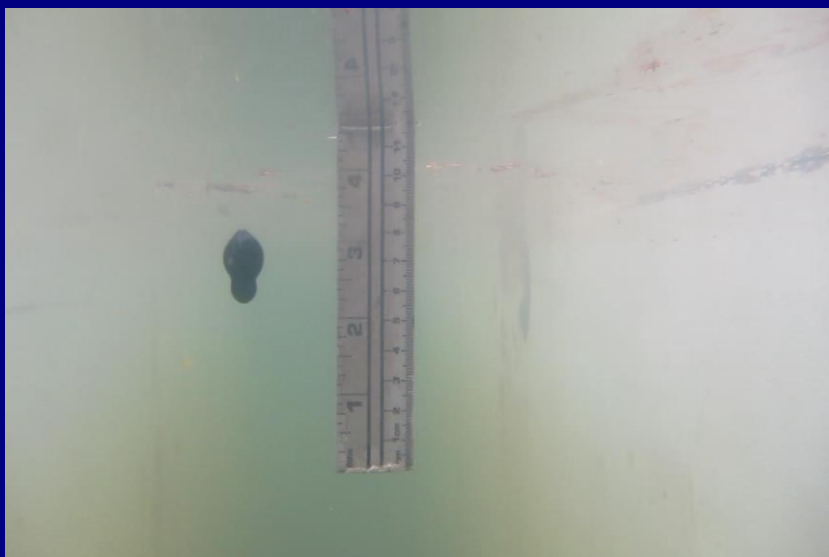
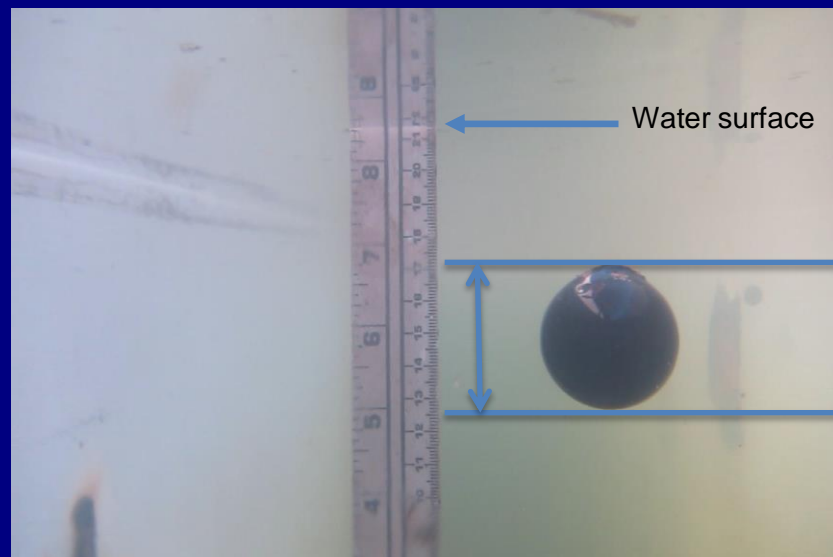
# Submerged Oil Balls at Day 6

- On day five, 42 mm of rainfall entered the wave tank experiment
- The average wind speed was 22 km/hr.
- The fresh water input created two saline layers in the tank
- The upper few inches of seawater had a measured salinity of 17 p.s.u. (density 1.016 g/cm<sup>3</sup>) and beyond that point the salinity measured 27 p.s.u. (density 1.027 g/cm<sup>3</sup>).
- Note: there are areas in Douglas Channel where the salinity is <20 ppt.

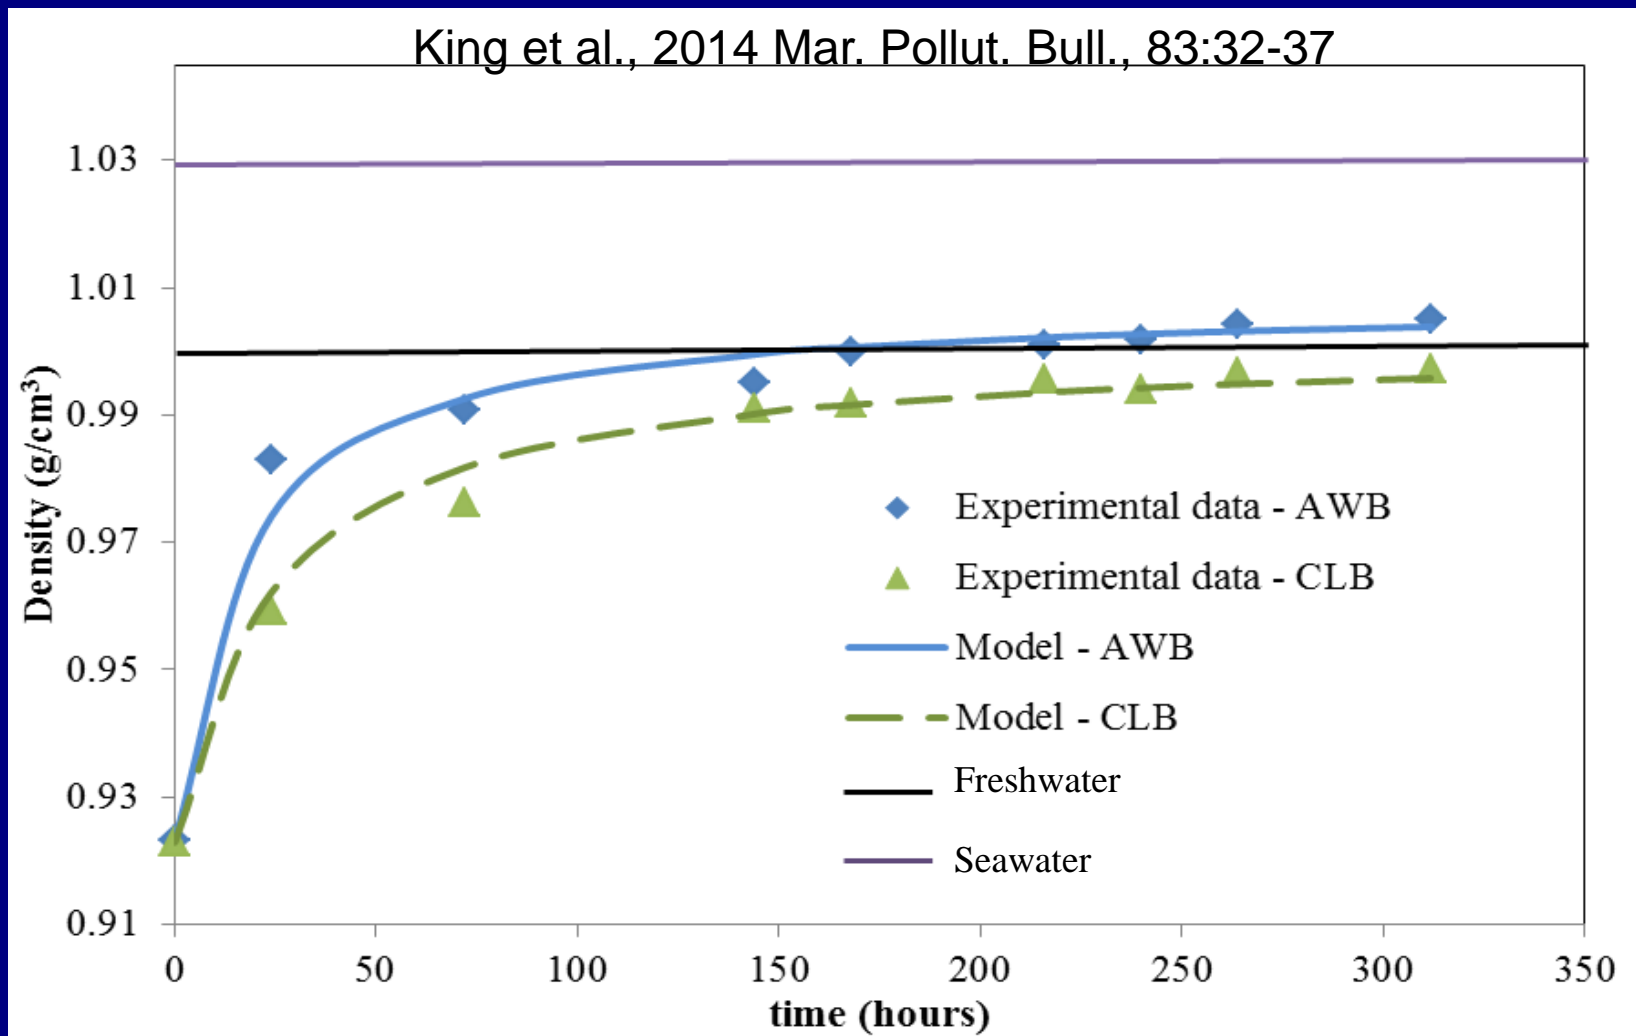
# Model: Natural Weathering of AWB and CLB

$$\text{AWB, } p = 0.9233 + (1.008 - 0.9233) \frac{t}{16+t}, R^2 = 0.98, t \text{ in hours}$$

$$\text{CLB, } p = 0.9229 + (1.0014 - 0.9229) \frac{t}{24+t}, R^2 = 0.99, t \text{ in hours}$$

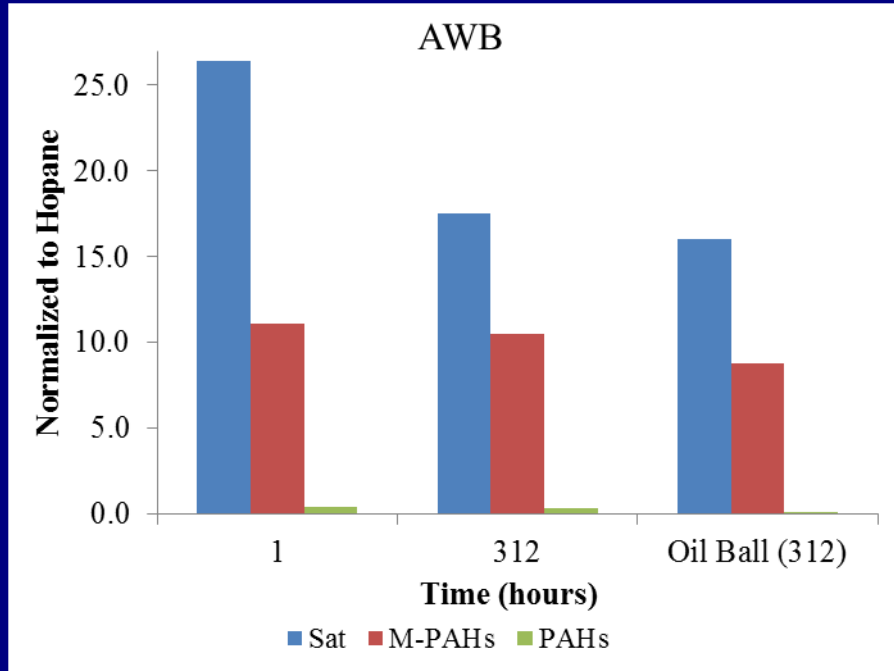
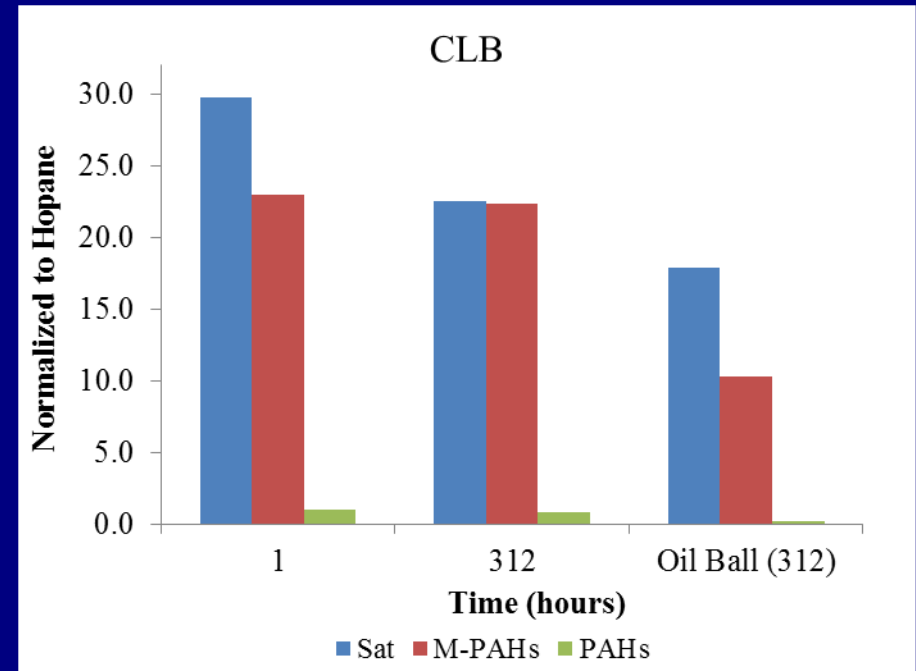
# GC-MS Data

- Note the M-PAHs bar graphs, these compound are more resistant to weathering.
- The composition of the tar ball more closely compares with AWB weathered product.

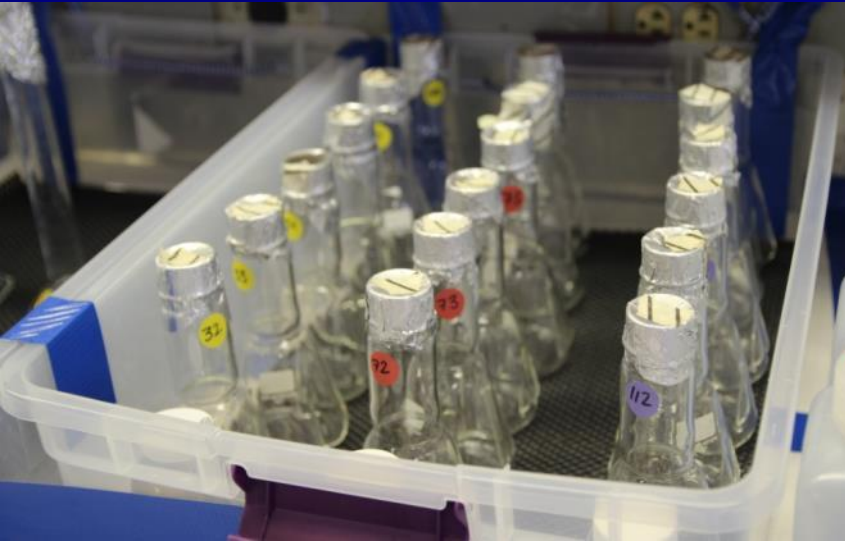
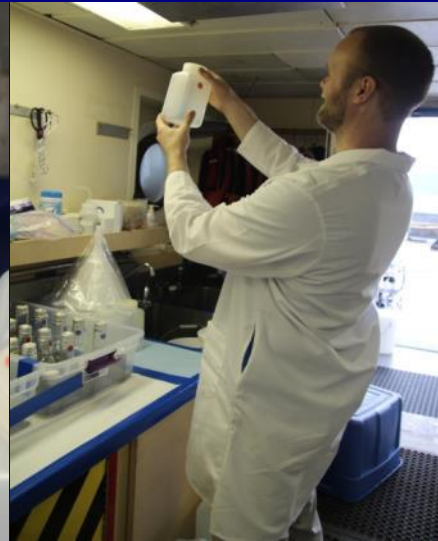
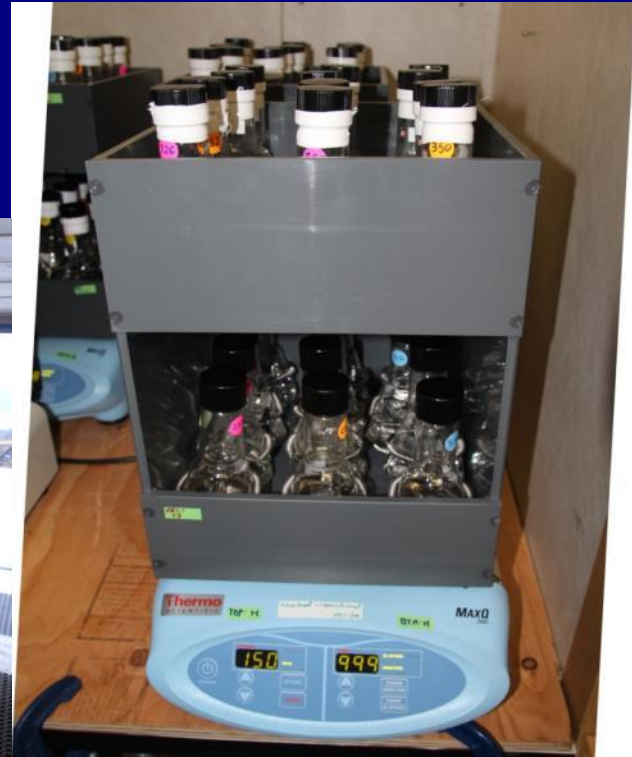
# Exsitu Microcosms

- 150 mL trypsinizing “baffle flasks” (Flasks, caps sterilized)
- Sterile controls (0.1  $\mu$ M filtration)
- Surface (5 m) seawater + amendments
- Incubated at ambient surface seawater temperature
- Mixed on orbital shakers at 150 rpm
- Triplicate treatments
- Chemistry sacrificed at 0, 3, 15, 28, and 42 days
- Microbiology sacrificed at 0, 3, and 42 days

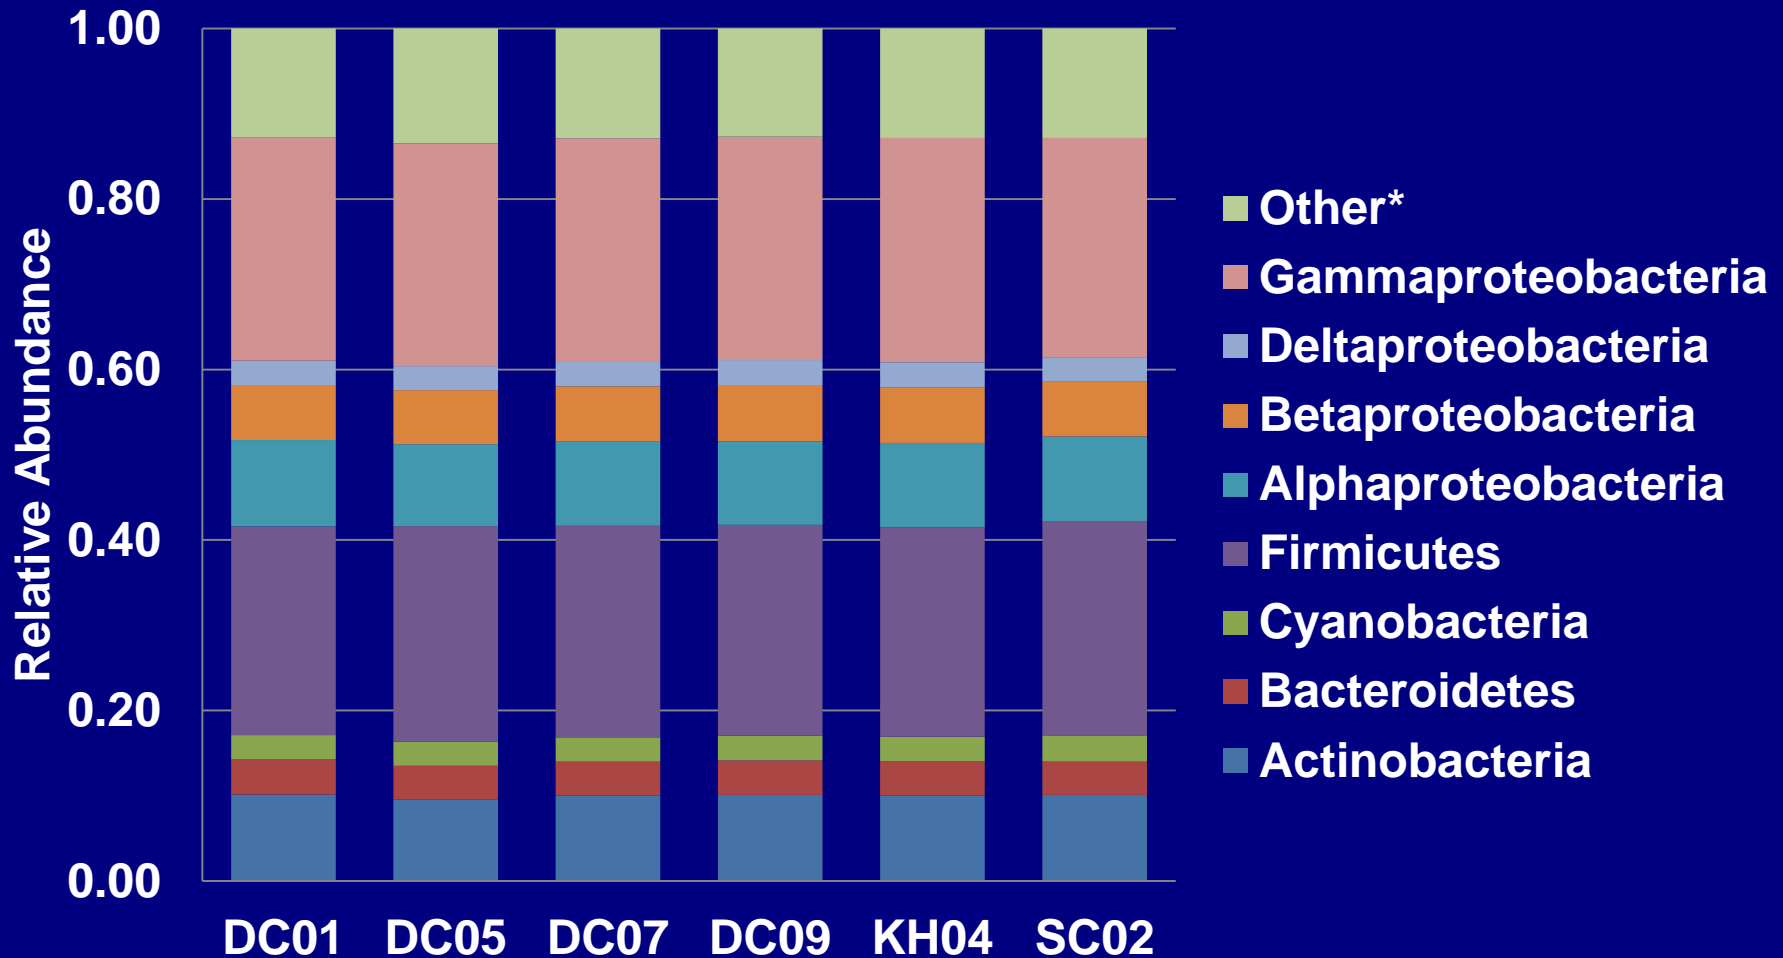
# Pacific: Bacterial Community Composition in Douglas Channel

**\*Other Bacteria include:** Acidobacteria, Aquificae, Chlamydiae, Chlorobi, Chloroflexi, Chrysiogenetes, Deferribacteres, Deinococcus-Thermus, Dictyoglomi, Elusimicrobia, Fibrobacteres, Fusobacteria, Gemmatimonadetes, Lentisphaerae, Nitrospirae, Planctomycetes, Poribacteria, Epsilonproteobacteria, unclassified (derived from Proteobacteria), Zetaproteobacteria, Spirochaetes, Synergistetes, Tenericutes, Thermodesulfobacteria, Thermotogae, unclassified (derived from Bacteria), Verrucomicrobia.

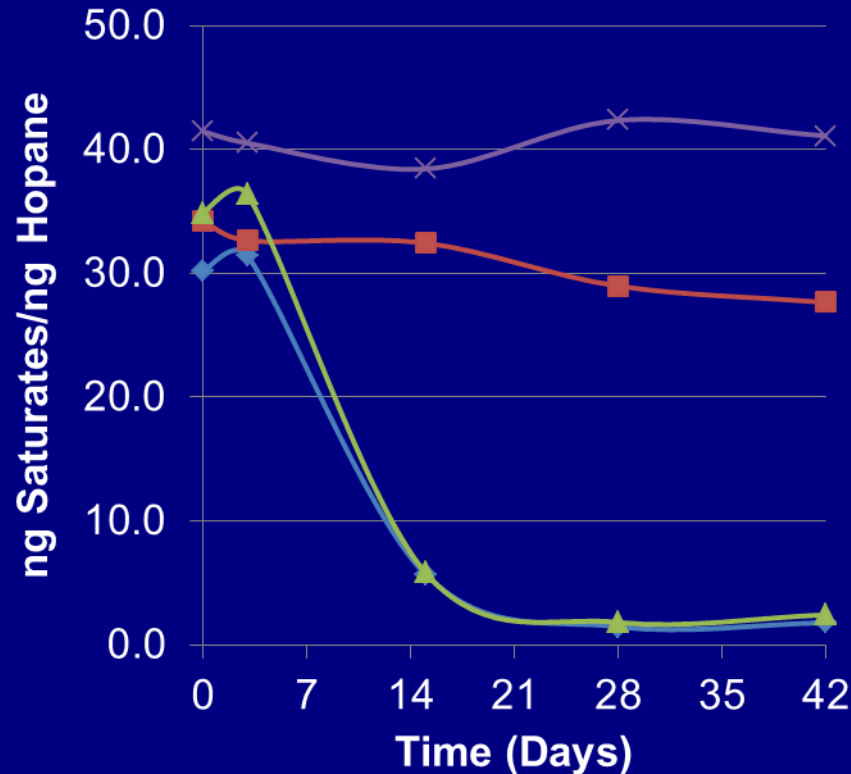
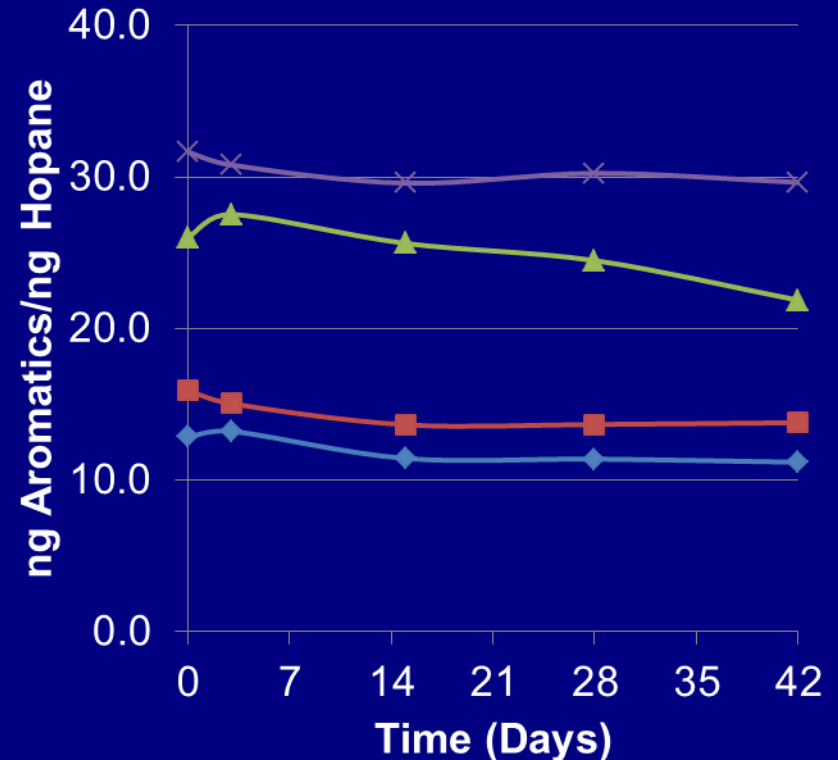
# Biodegradation of Dilbit Products with Microbes Indigenous to Douglas Channel Area

◆ AWB (Sat)      ■ AWB (Sat Control)      ◆ AWB (Aro)      ■ AWB (Aro Control)

▲ CLB (Sat)      ✕ CLB (Sat Control)      ▲ CLB (Aro)      ✕ CLB (Aro Control)

$$\text{Percent Biodegradation} = \left[ 1 - \frac{\left(\frac{C}{H}\right)_t}{\left(\frac{C}{H}\right)_0} \right] \times 100$$

Oils Pre-weathered: ~8% AWB and ~7% CLB

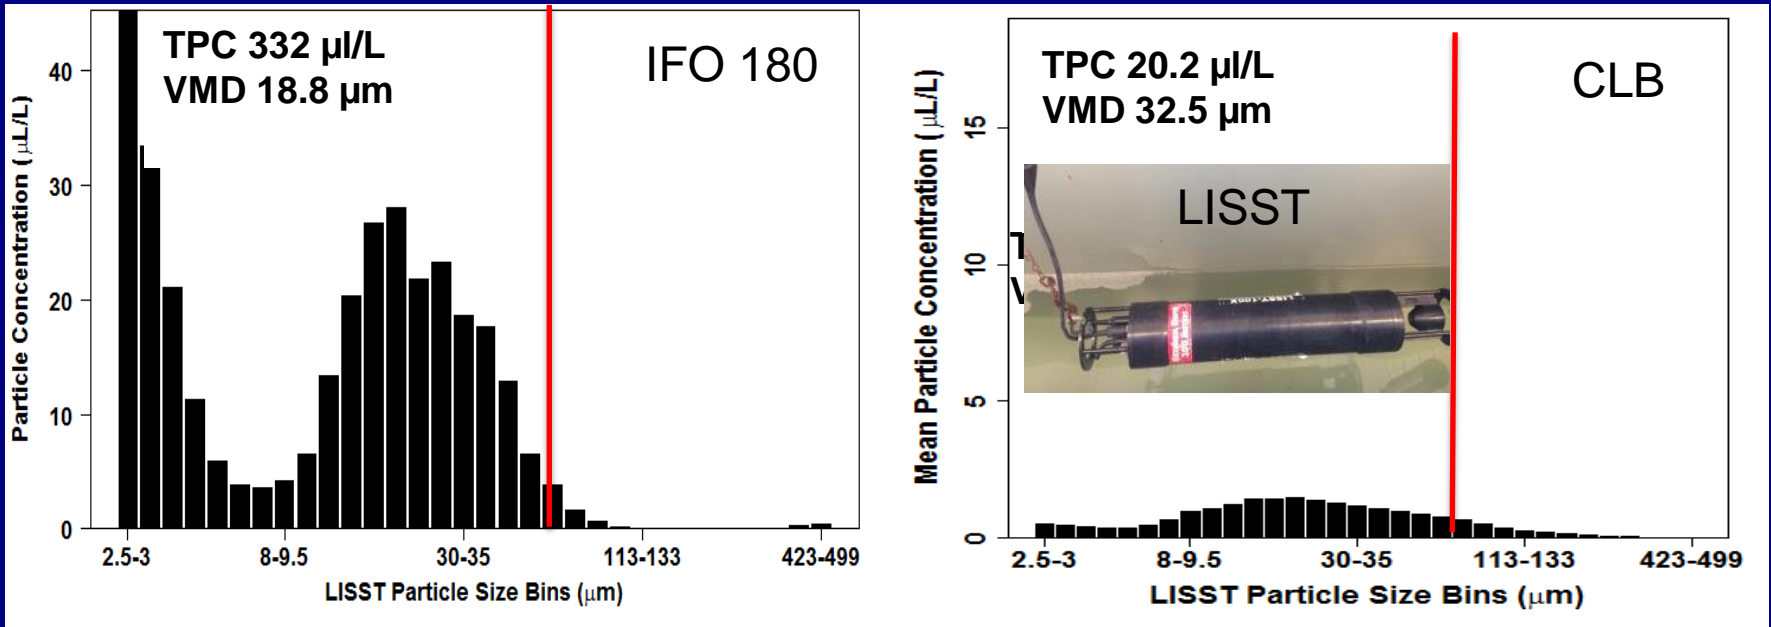
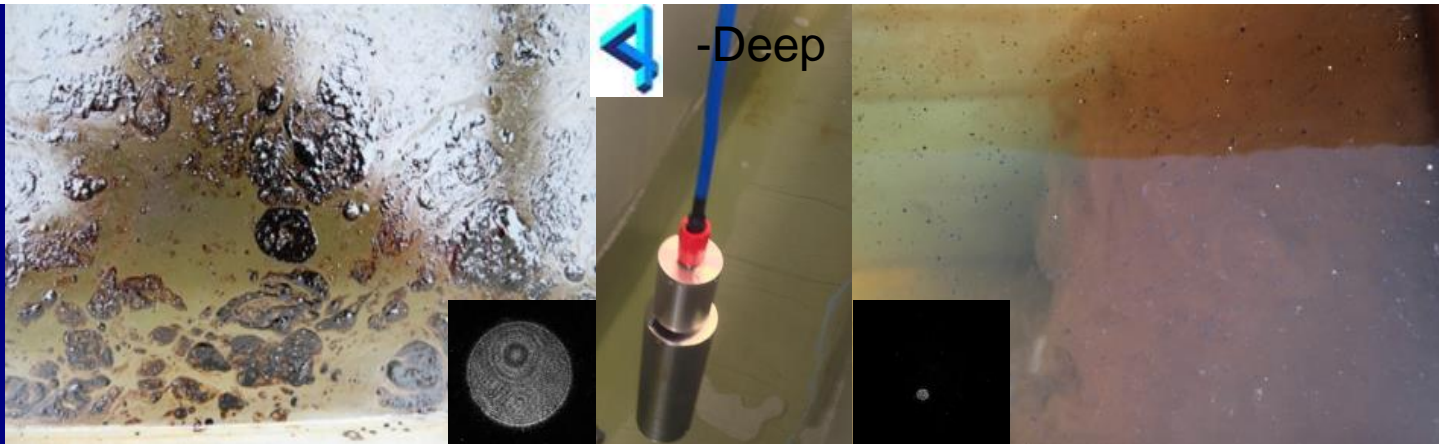
# LISST: Particle Size Distribution Plots

1.13mm droplet vs 65 $\mu\text{m}$  droplet

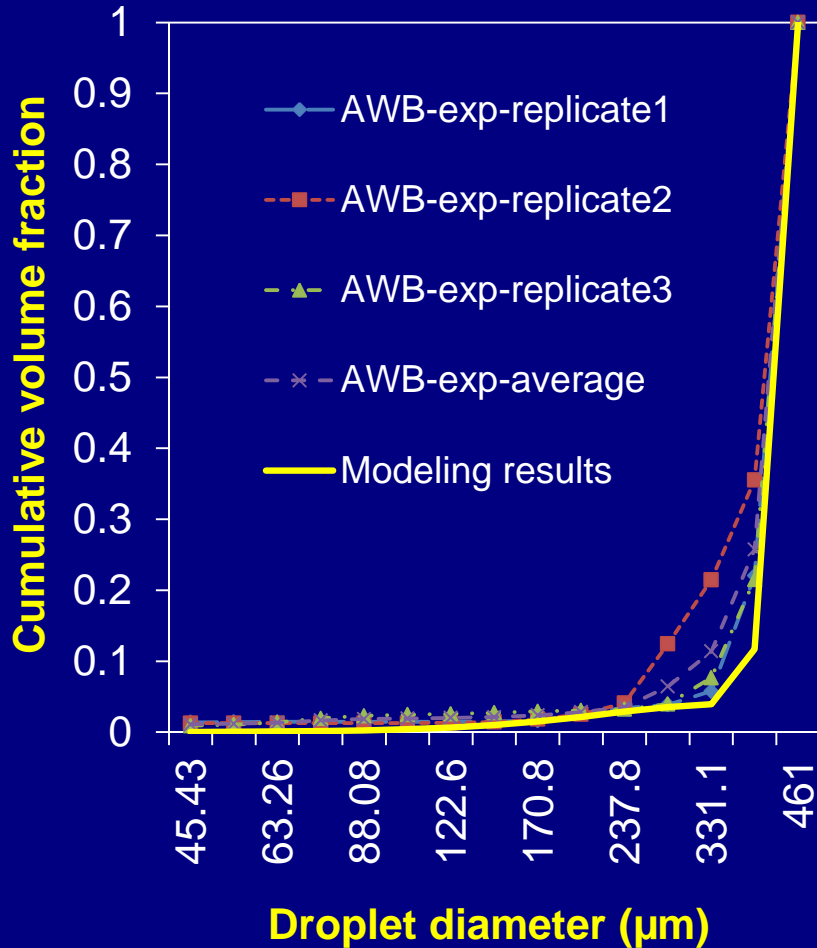
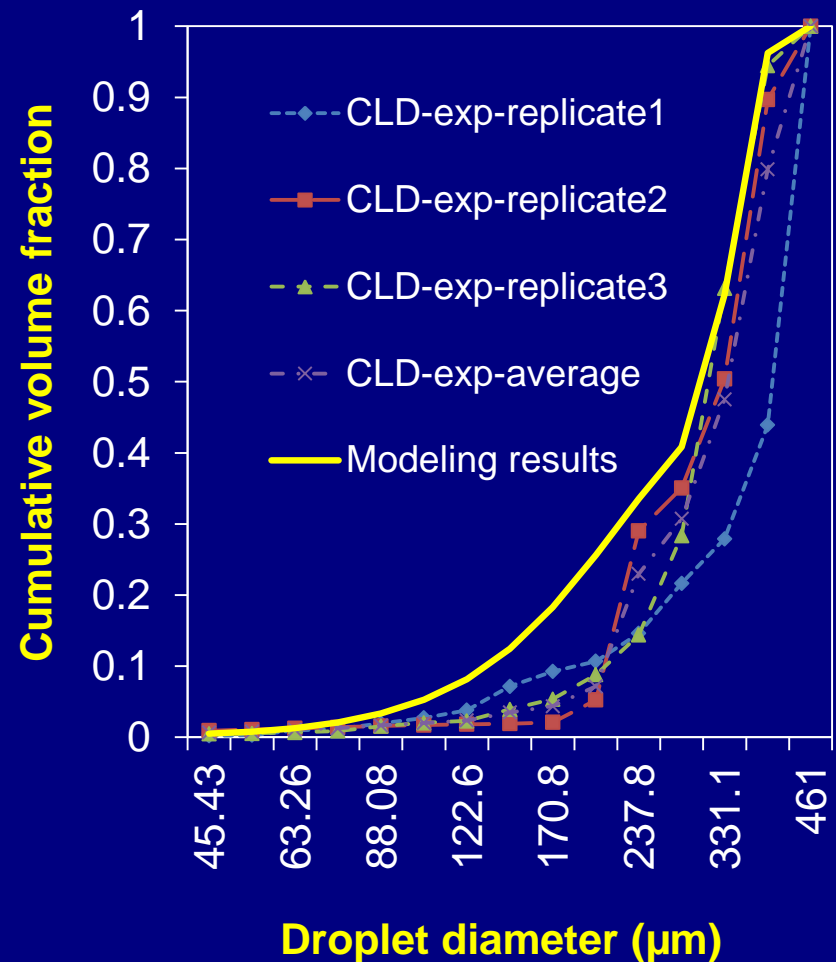
# VDRROP model of the oil droplet size distribution (1.2 m from oil release point)

Volume droplet formation model fitted to experimental data from wave tank studies

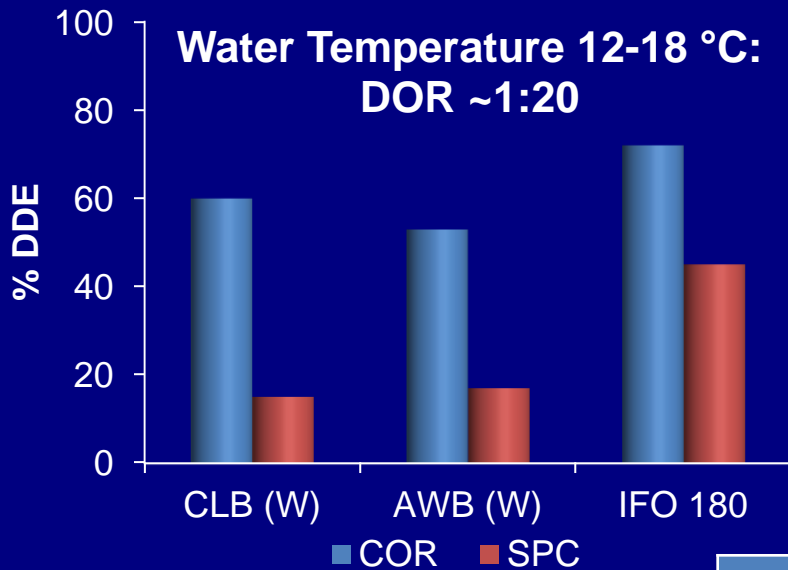
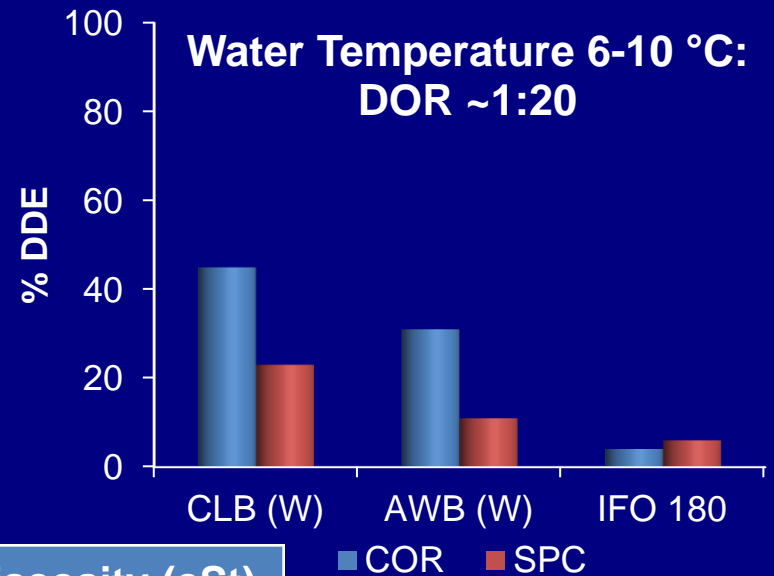
# Comparison of Diluted Bitumen with IFO 180

Oils Pre-weathered: ~8% AWB and ~7% CLB

Oil	Viscosity (cSt)	
	15 °C	8 °C
<b>CLB</b>	1330	2780
<b>AWB</b>	1720	2980
<b>IFO 180</b>	2471	5067

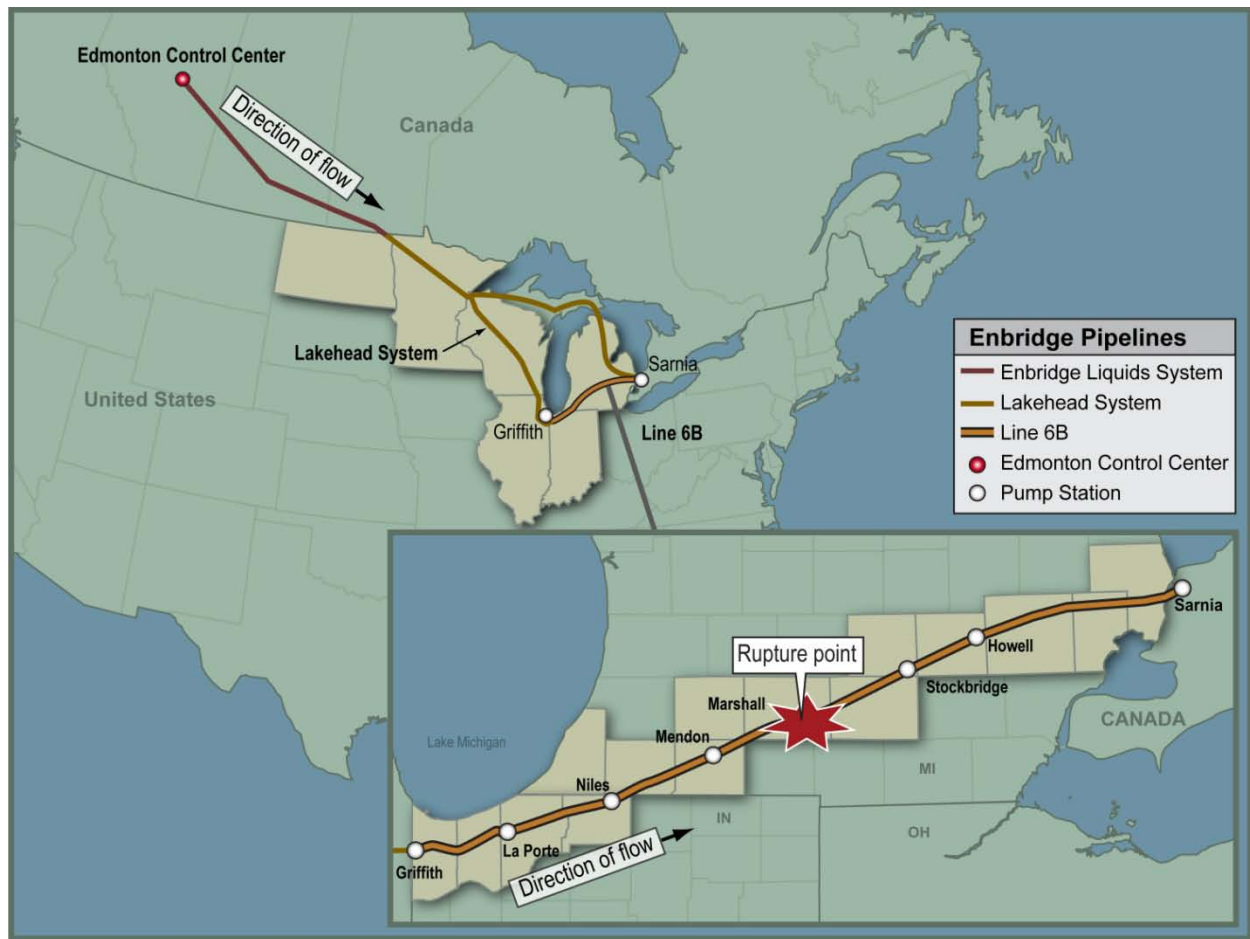
**Figure 1.** Enbridge’s Liquids System and the 1,900-mile Lakehead System (the U.S. portion). Inset shows Line 6B, the 293-mile extension from Griffith to Sarnia installed in 1969.

On Sunday, July 25, 2010, at 5:58 p.m., eastern daylight time,<sup>1</sup> a segment of a 30-inch-diameter pipeline (Line 6B), owned and operated by Enbridge Incorporated (Enbridge) ruptured in a wetland in Marshall, Michigan, about 0.6 mile downstream of the Marshall Pump Station (PS), releasing about 843,444 gallons of crude oil.<sup>2</sup> The accident pipeline was part of Enbridge's liquid pipeline system that originates in Edmonton, Alberta, Canada, and terminates in Sarnia, Ontario, Canada. The 1,900-mile U.S. portion, known as the Lakehead System, consists of pipelines of various diameters and ages operated from a control center in Edmonton. Line 6B is a 293-mile section of the Lakehead System, which crosses the state of Michigan joining Griffith, Indiana, to Sarnia. (See figure 1.)
