**RE: Hearing Order OH-001-2014**  
**Trans Mountain Pipeline ULC (Trans Mountain)**  
**Application for the Trans Mountain Expansion Project (Project)**  
**Elizabeth May Written Evidence**

# The Behaviour and Environmental Impacts of Crude Oil Released into Aqueous Environments

**Meeting of the Royal Society of Canada's Expert Panel on  
*The Behaviour and Environmental Impacts of Crude Oil Released into Aqueous Environments*  
Wednesday, February 4, 2015**

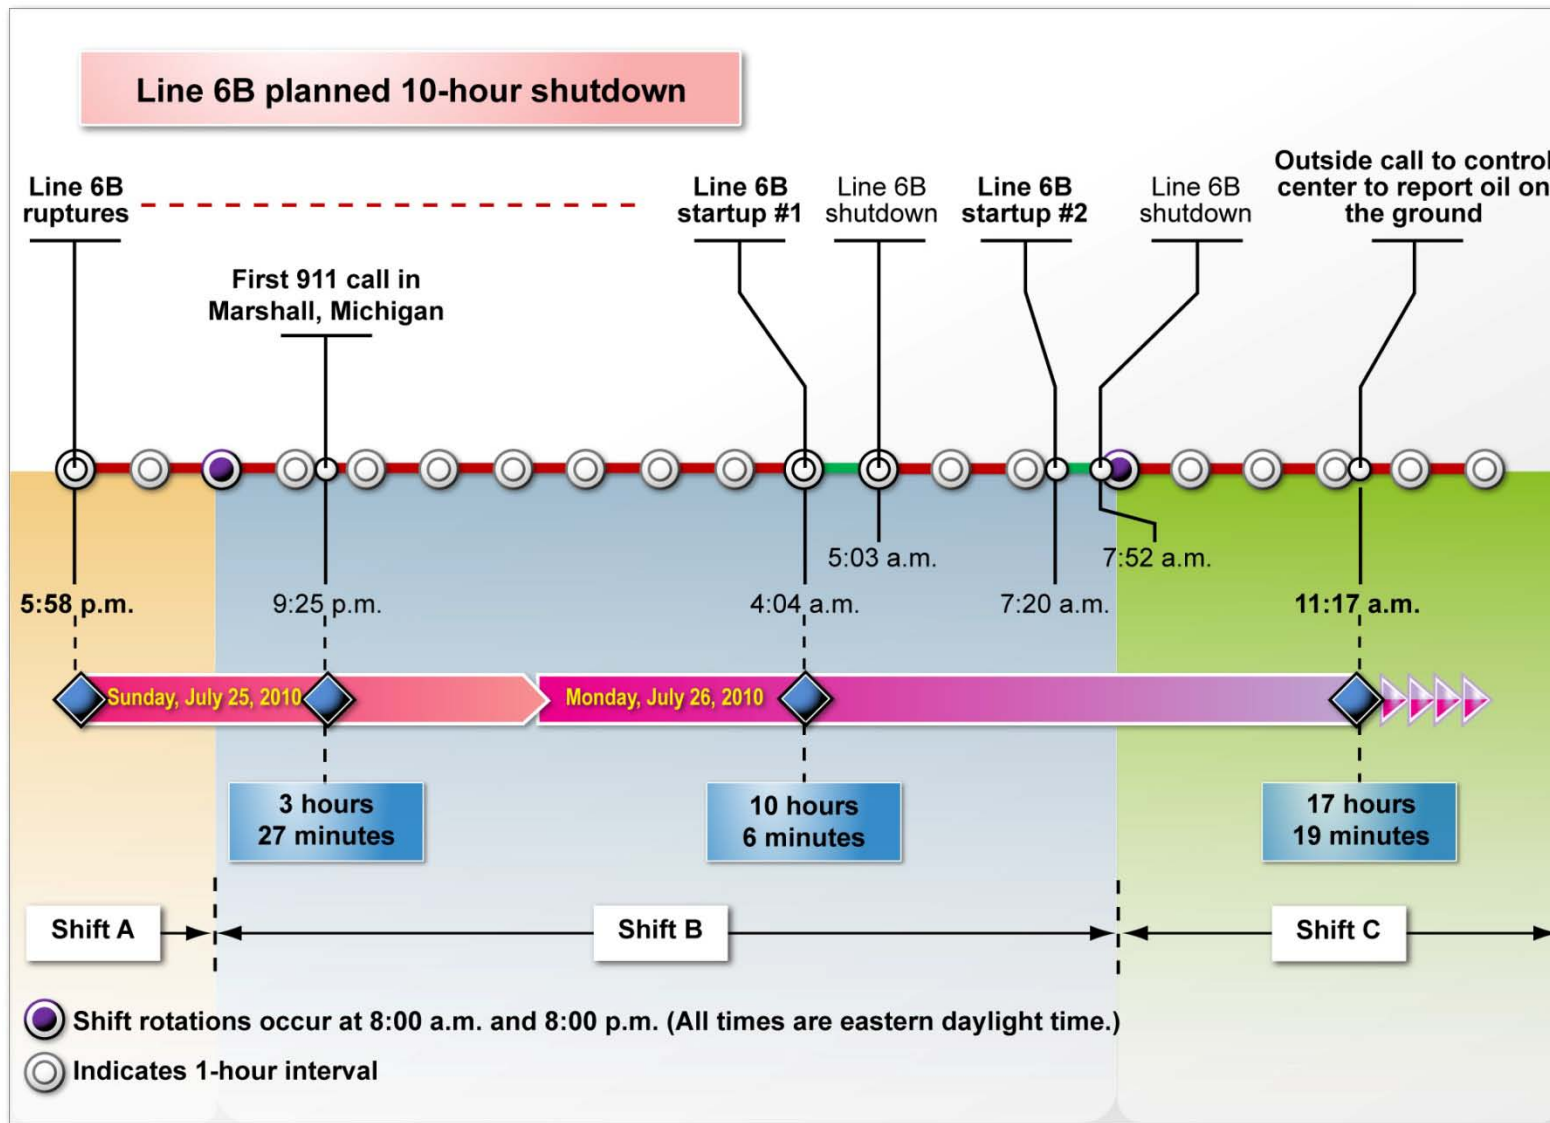
**Figure 5.** Key events timeline of the Line 6B rupture in Marshall, Michigan, showing the events from the time of rupture on July 25, 2010, to the time of discovery on July 26, 2010.

Figure 5 shows a timeline highlighting the accident events that spanned over 17 hours from the time of the rupture until the Enbridge control center was made aware of it. Figure 6 shows the key Enbridge staff involved.

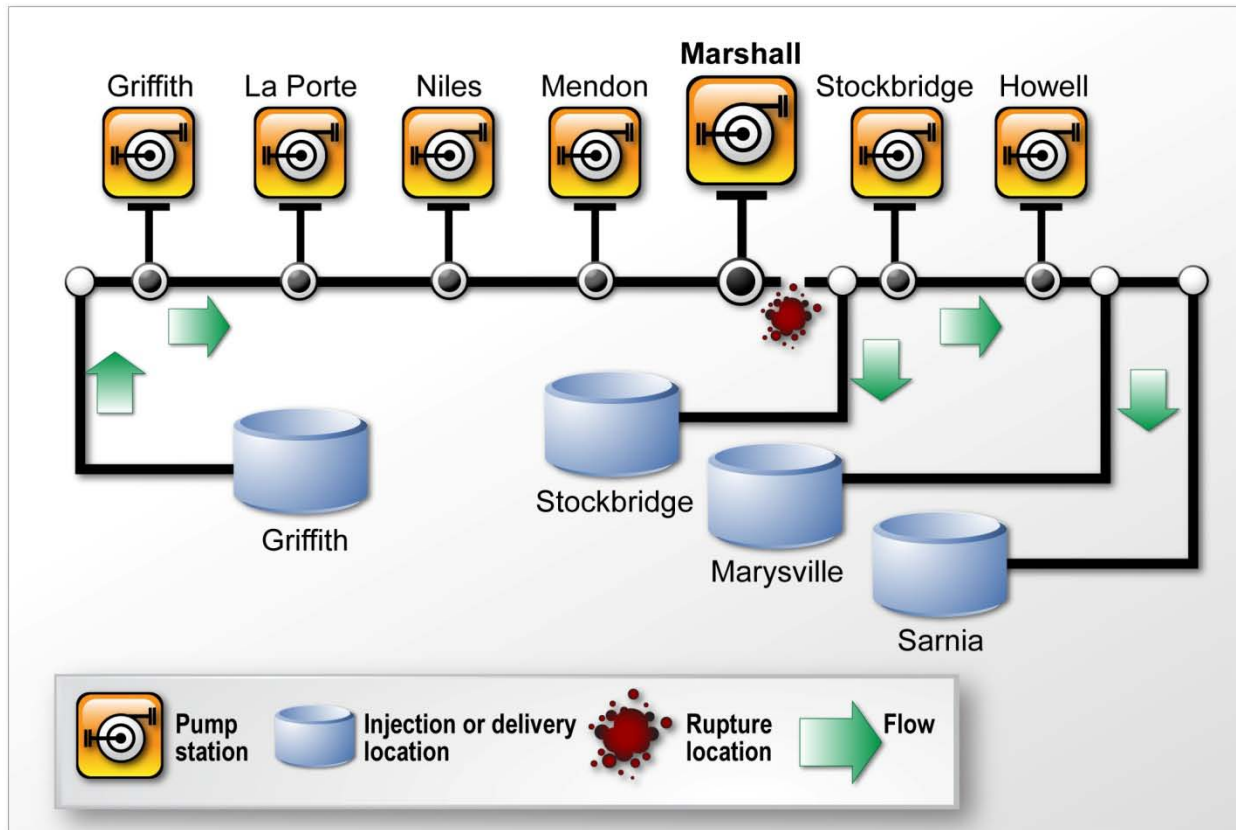
**Figure 7.** Simplified schematic of Line 6B, showing pump stations and delivery locations.

The planned shutdown of Line 6B was scheduled to begin following the last crude oil delivery to the Stockbridge Terminal, located downstream of the Marshall PS (see figure 7). A shutdown was to be performed by pipeline operator A1, sequentially, in the direction of flow, by turning off the pumps at the following PSs: Griffith, La Porte, Niles, Mendon, and Marshall. The shutdown was started at 5:55 p.m. by stopping two pumps at the Griffith PS and a pump at the La Porte PS. At 5:57 p.m., operator A1 increased the upstream pressure at a pressure control valve<sup>8</sup> at the Stockbridge Terminal before stopping a pump at the Niles PS and a pump at the Mendon PS about 1 minute later.

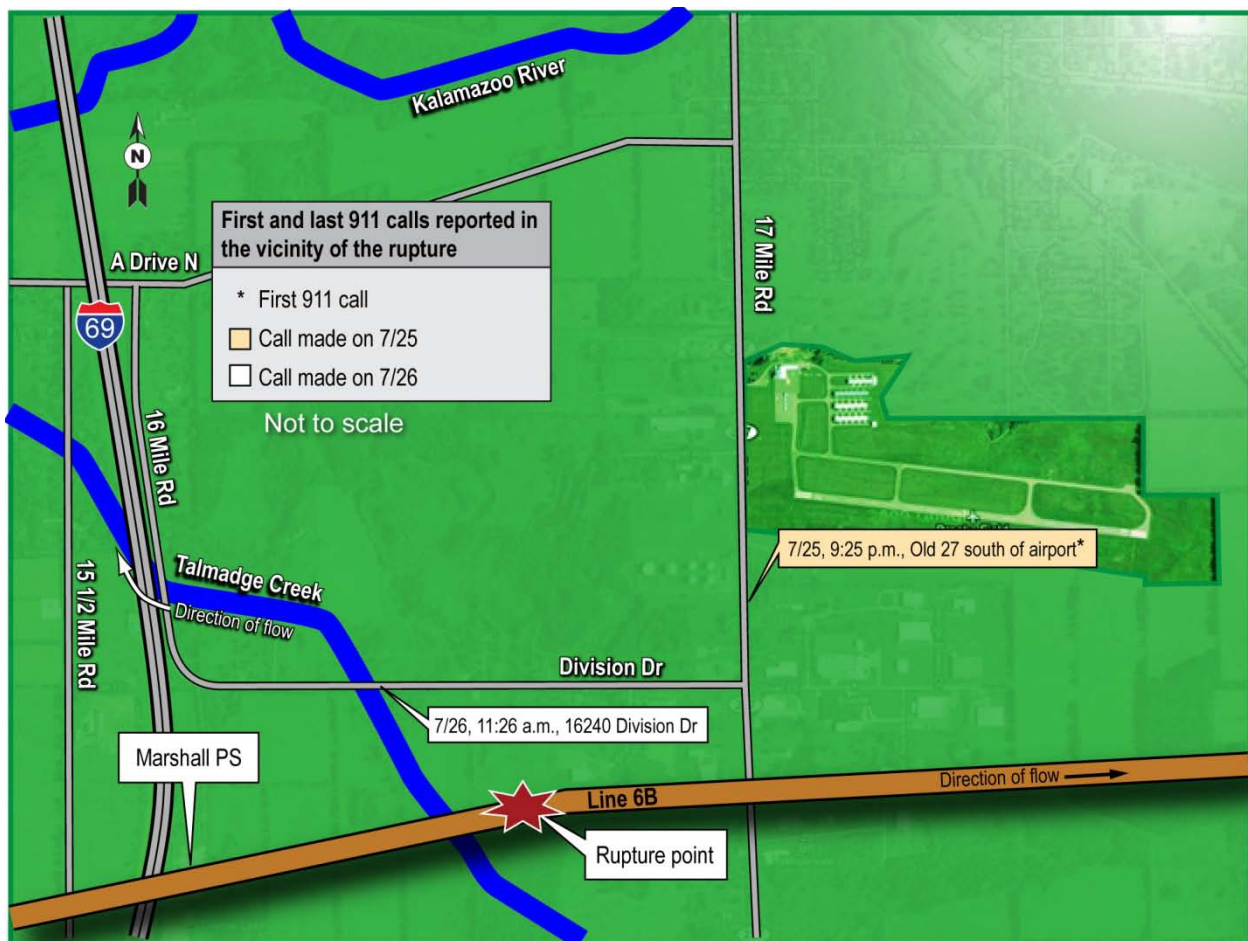
**Figure 8.** Emergency response and 911 calls from nearby residents. First and last calls are noted.

Marshall City Fire Department personnel responded to the area near the airport and requested the Marshall Township Fire Department to respond as well. To find the source of the odor, fire department personnel investigated several pipeline facilities and industrial buildings around Division Drive and 17 Mile Road, using a combustible gas indicator<sup>21</sup> to try to locate the origin of the odor. No combustibles were detected. The Michigan Gas Utilities senior service technician crossed paths with some of the fire department personnel also trying to locate the source; he found no evidence of a gas leak. The fire department personnel departed the scene at 10:54 p.m. to return to the station. At 11:33 p.m., an employee at a business called 911 to report a natural gas odor. The 911 dispatcher explained that the fire department had already responded to calls in the area, and no more personnel were dispatched.<sup>22</sup> (See figure 8.)

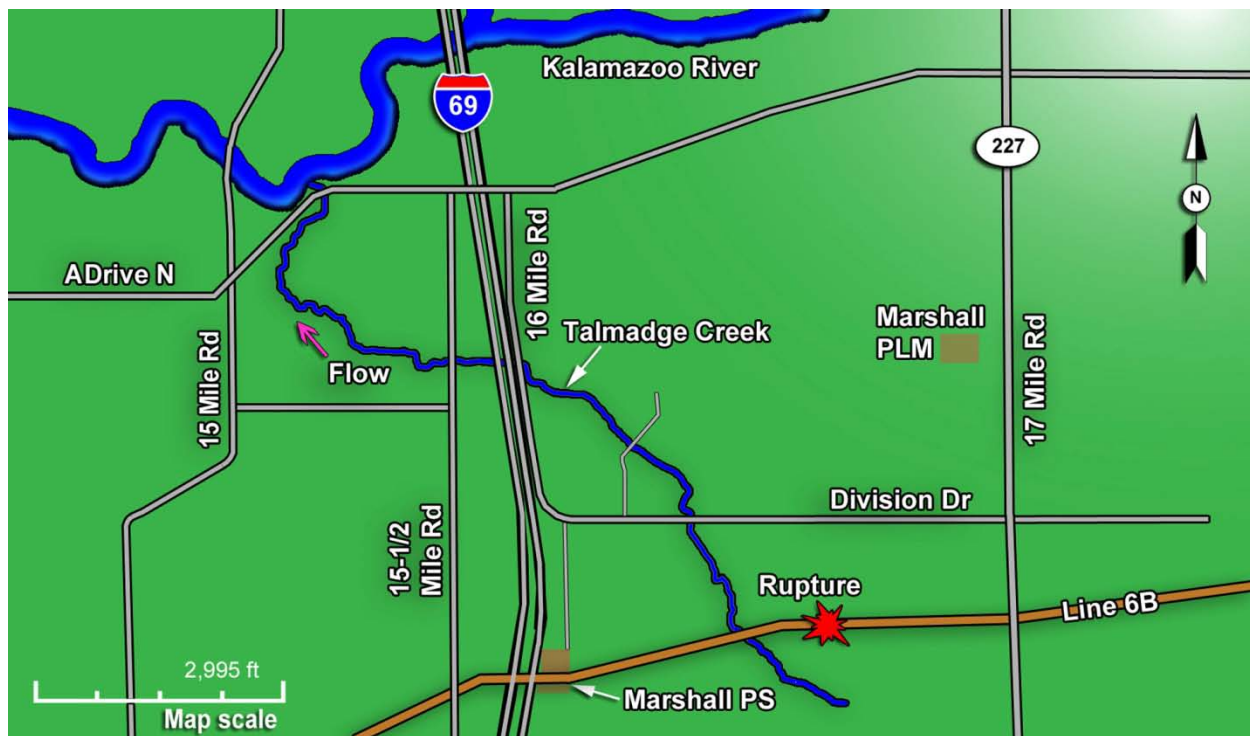
**Figure 9.** Area between rupture site and the Kalamazoo River where first responders concentrated efforts to contain the released oil.

The four-person crew returned to the Marshall PLM shop and retrieved a vacuum truck, a work truck, a semi-truck, and an oil boom trailer. About 12:10 p.m., they returned to A Drive North and installed a double 20-foot length of sorbent boom across Talmadge Creek, where they observed only a little oil flowing. They also installed 20-foot lengths of sorbent boom across Talmadge Creek upstream of A Drive North and at a culvert on the south side of A Drive North. The Enbridge crossing coordinator told NTSB investigators that the Marshall PLM crew was not aware of the severity of the oil spill when it used these initial oil containment measures. The Enbridge first responders did not have an estimate of released volumes when they began their efforts to contain the oil. (See figure 9 for a map of the area around the rupture site where response efforts began.)

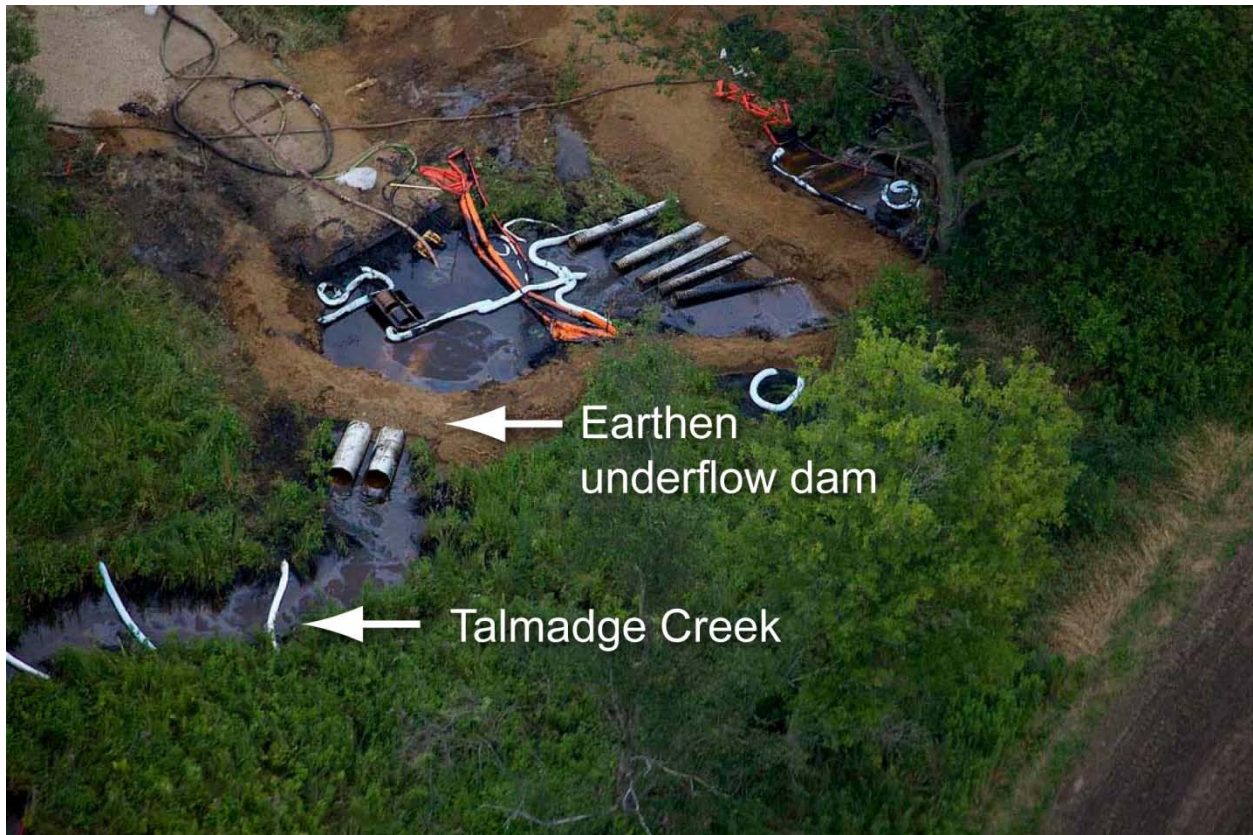
**Figure 10.** Underflow dam on Talmadge Creek on July 30, 2010.

Working with a six-person crew, the Marshall PLM supervisor constructed an earthen underflow dam, which consists of a mound of soil holding back oil-contaminated water with pipes submerged on the dam side and rising toward the discharge end. The angle of the pipe allows the deeper water in the dam to flow downstream, preventing the contaminated surface waters from flowing into Talmadge Creek. (See figure 10.)

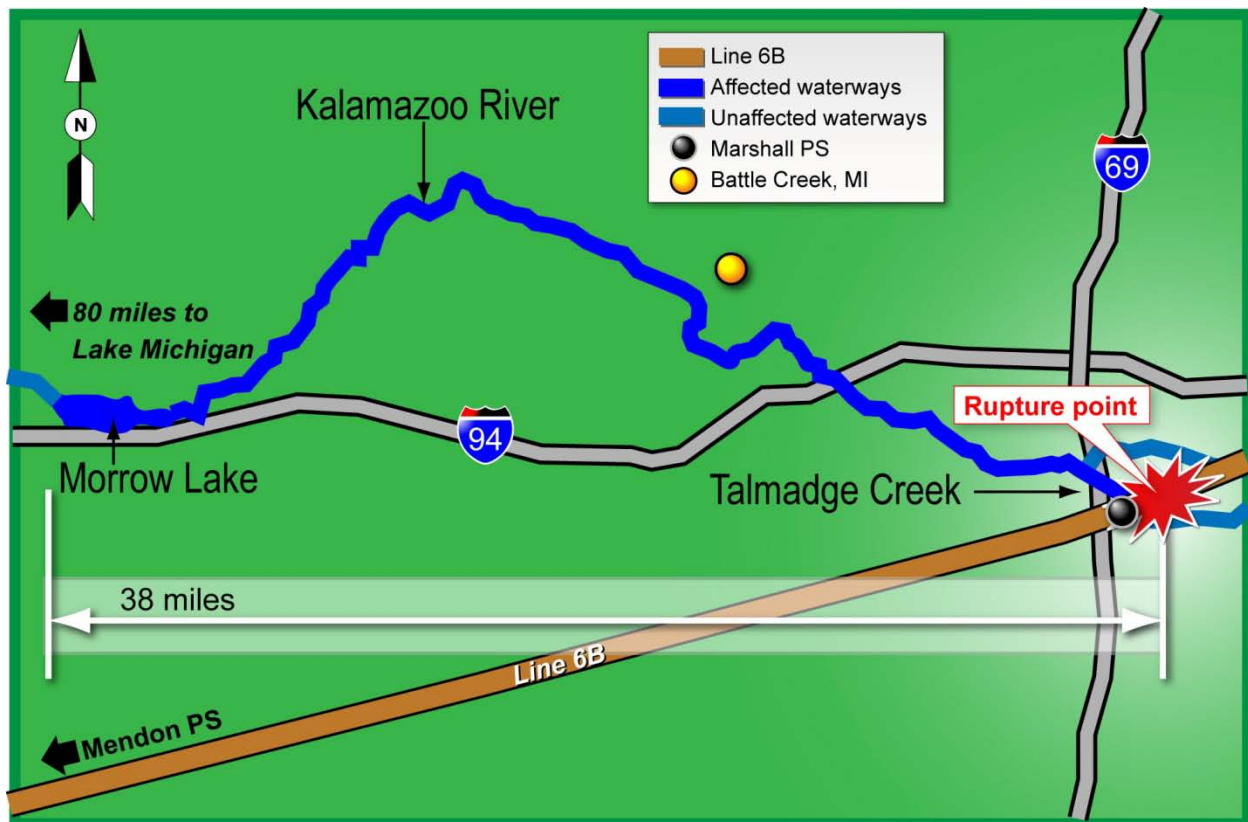
**Figure 19.** Map showing rupture location and affected waterways from Talmadge Creek to Morrow Lake.

In the days following the accident, Enbridge and its contractors established about 33 oil spill containment-and-control points (from the release site to the west end of Morrow Lake in Kalamazoo County, covering about 38 miles of the river). (See figure 19.) The control points consisted of a variety of oil containment strategies, including underflow dams, oil booming, and sorbent booming. Vacuum trucks and oil skimmers were used to remove oil at these locations.

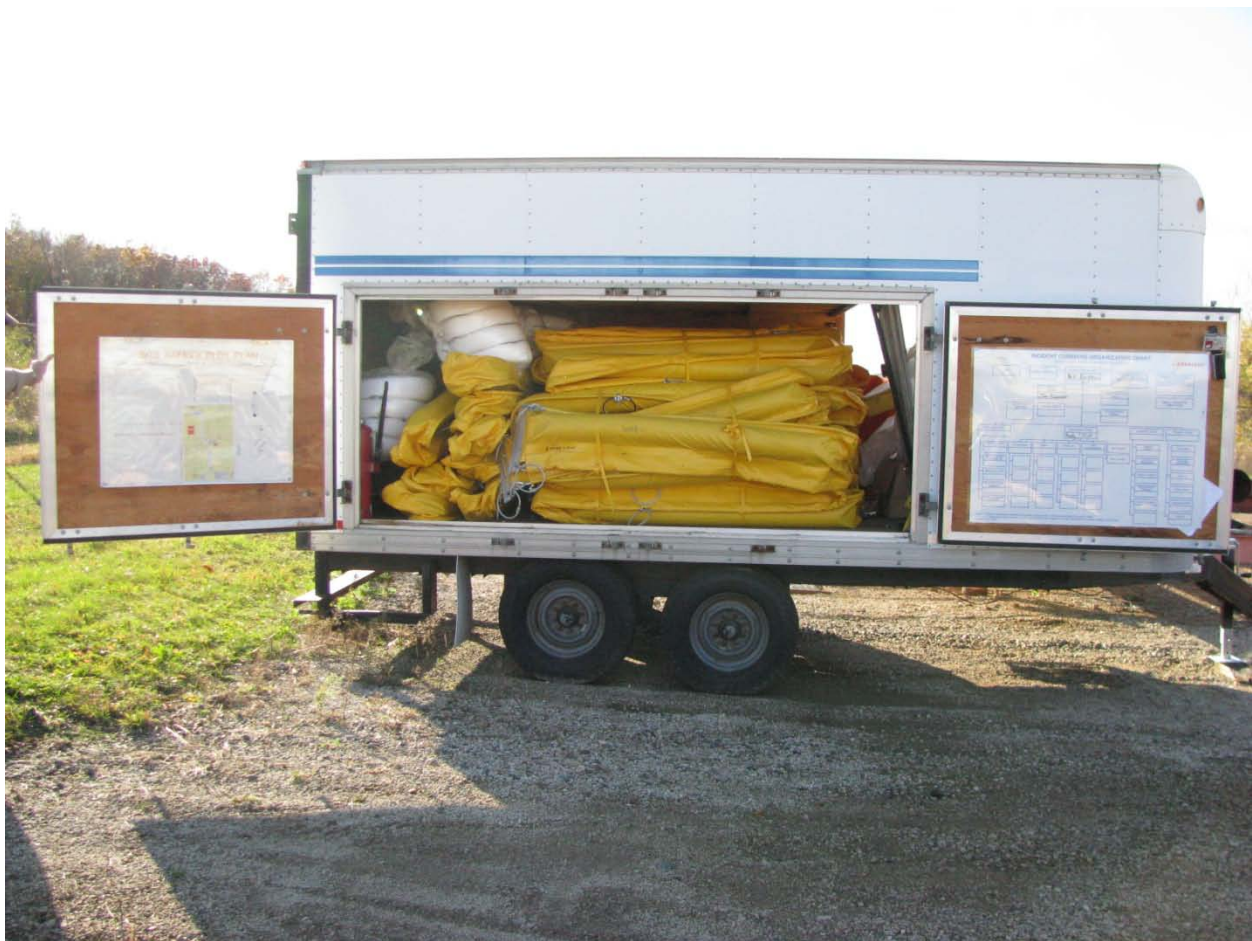
**Figure 20.** Enbridge PLM emergency response trailer containing the company's Tier 1 oil containment equipment, October 17, 2010.

Enbridge's plan states that the company owns and maintains emergency response equipment throughout its Chicago region at 13 office locations and strategic locations, including the Marshall, Michigan, PLM shop. The plan lists the amounts and types of spill response equipment maintained at each PLM station for responding to a worse-case discharge, including the Marshall PLM. According to the plan, the single Marshall PLM inventory response trailer (see figure 20) was packed with 1,100 feet of river containment boom; 200 feet of small containment boom; 200 feet of sorbent boom; and 1,000 sorbent pads to respond to the stated worst-case discharge of 1,111,152 gallons. In addition to the trailer, the PLM shop equipment included 3 skimmers, 18 pumps, 1 storage tank, 3 boats, and a single 1,680- to 2,520-gallon-capacity vacuum truck. According to Enbridge's interpretation of response planning regulations, this equipment constitutes its Tier 1 response resources.

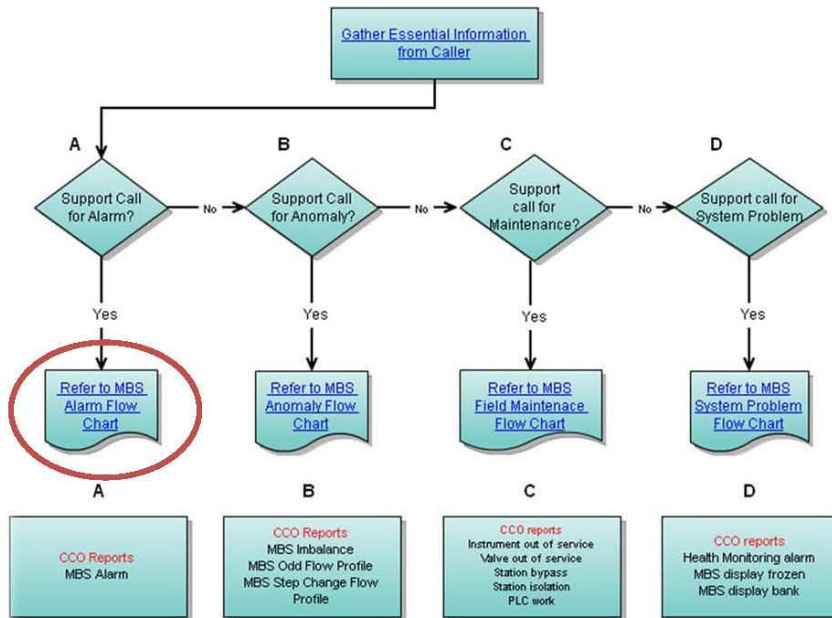
- Using the flow chart to respond to a 5-min MBS alarm related to column separation.

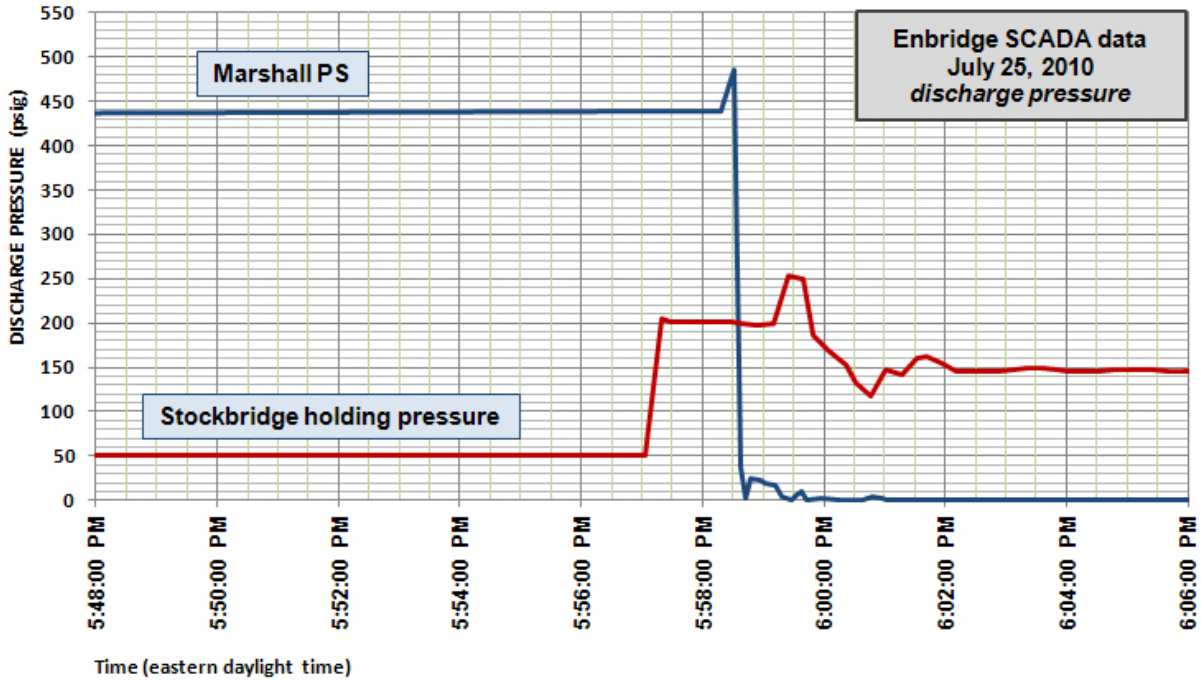
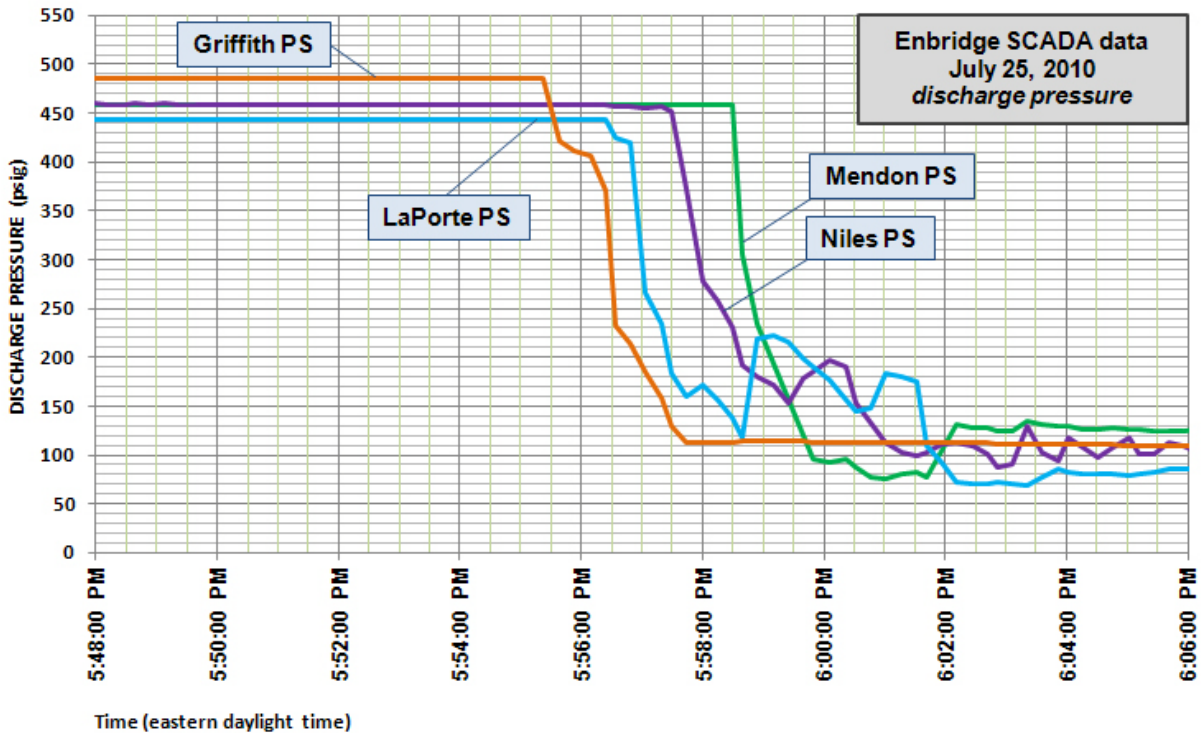
SCADA Discharge Pressure Recorded at the Time of Rupture

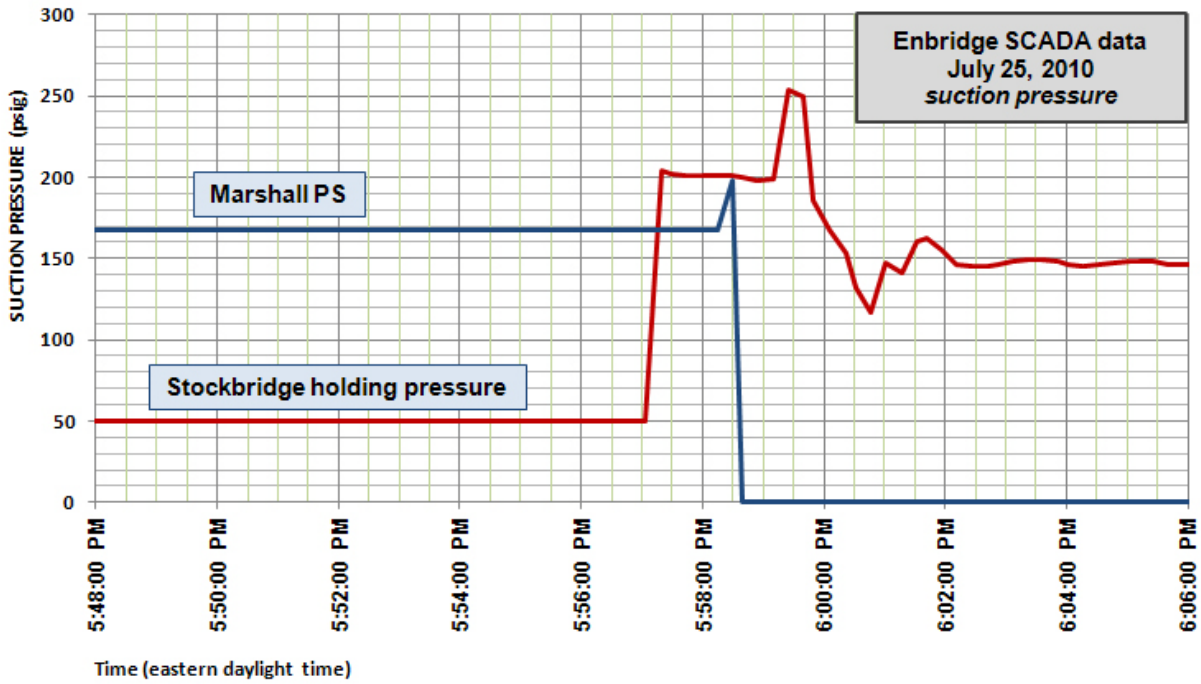
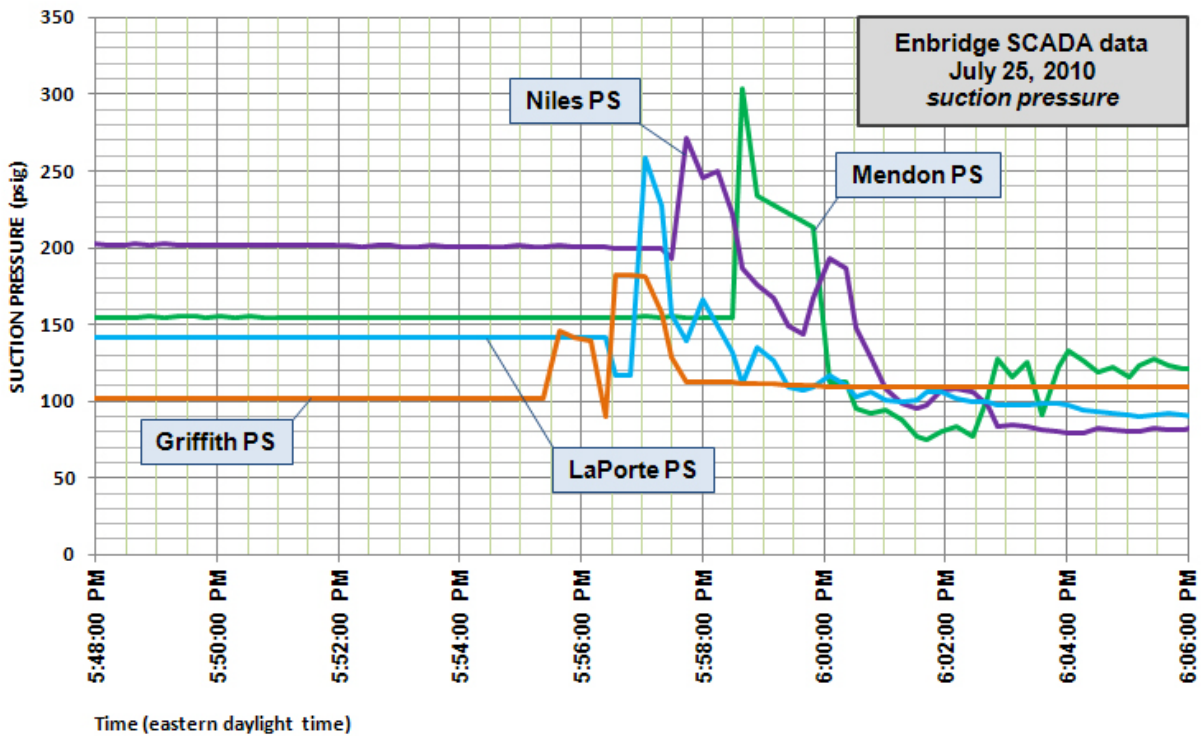
SCADA Suction Pressure Recorded at the Time of Rupture

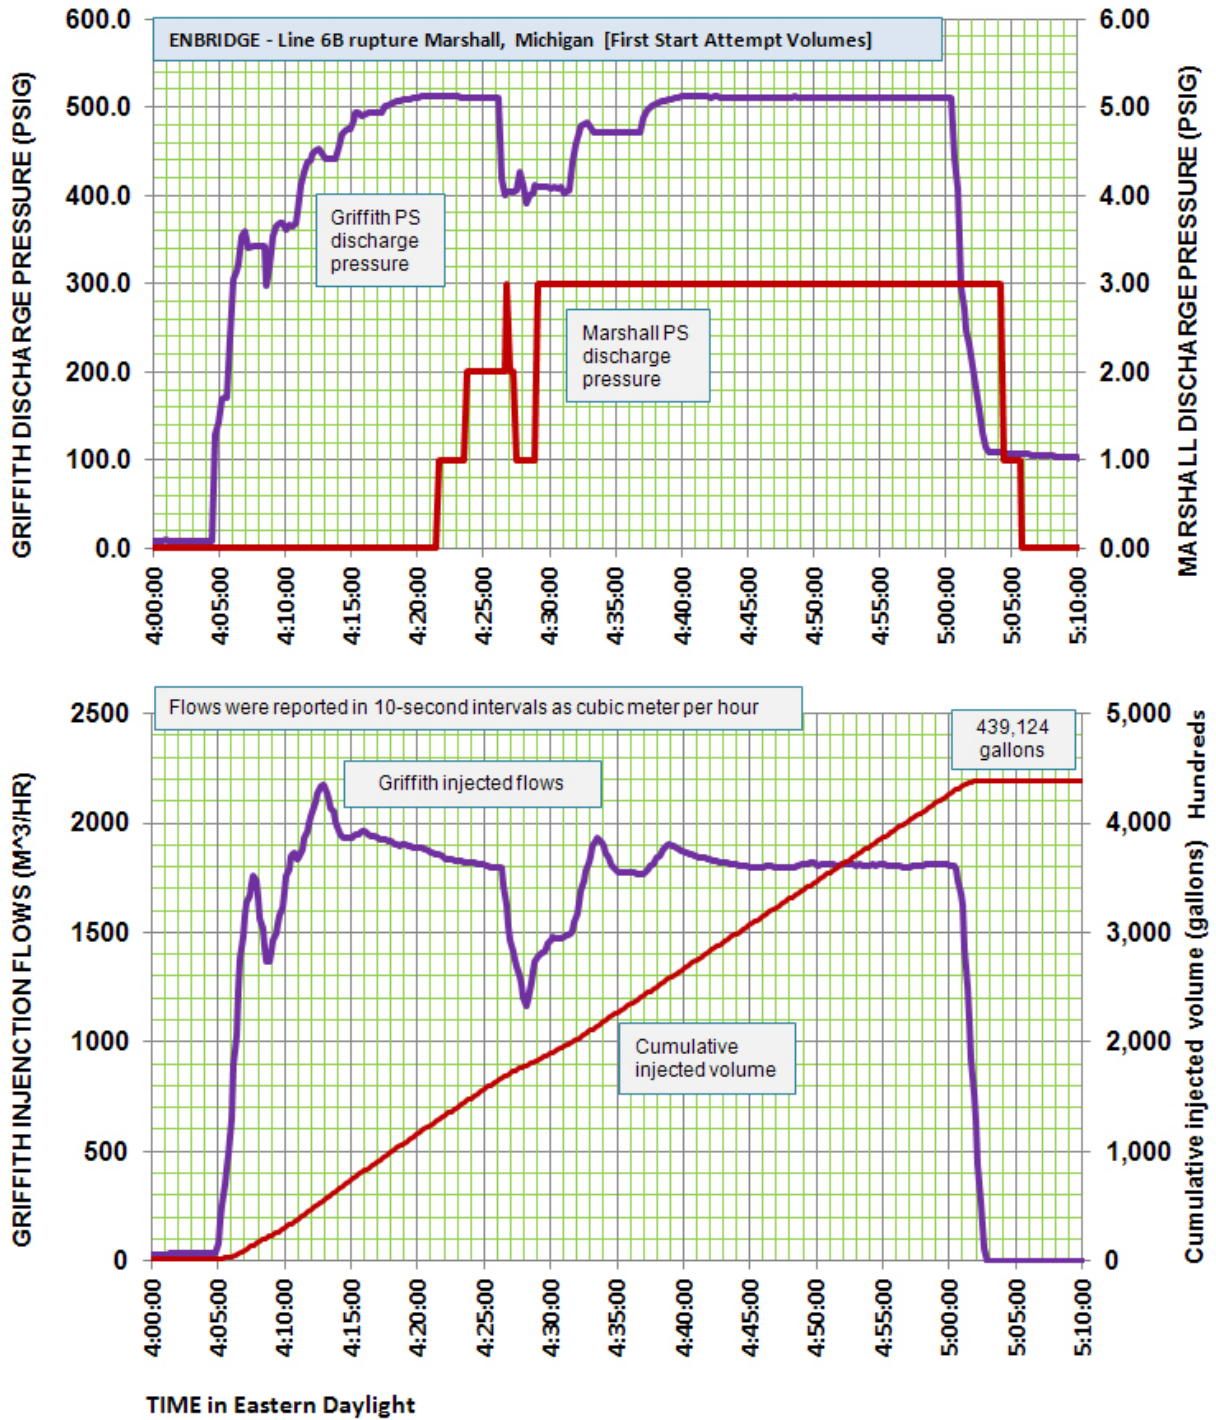
SCADA Pressure and Volumes Pumped—Startup One

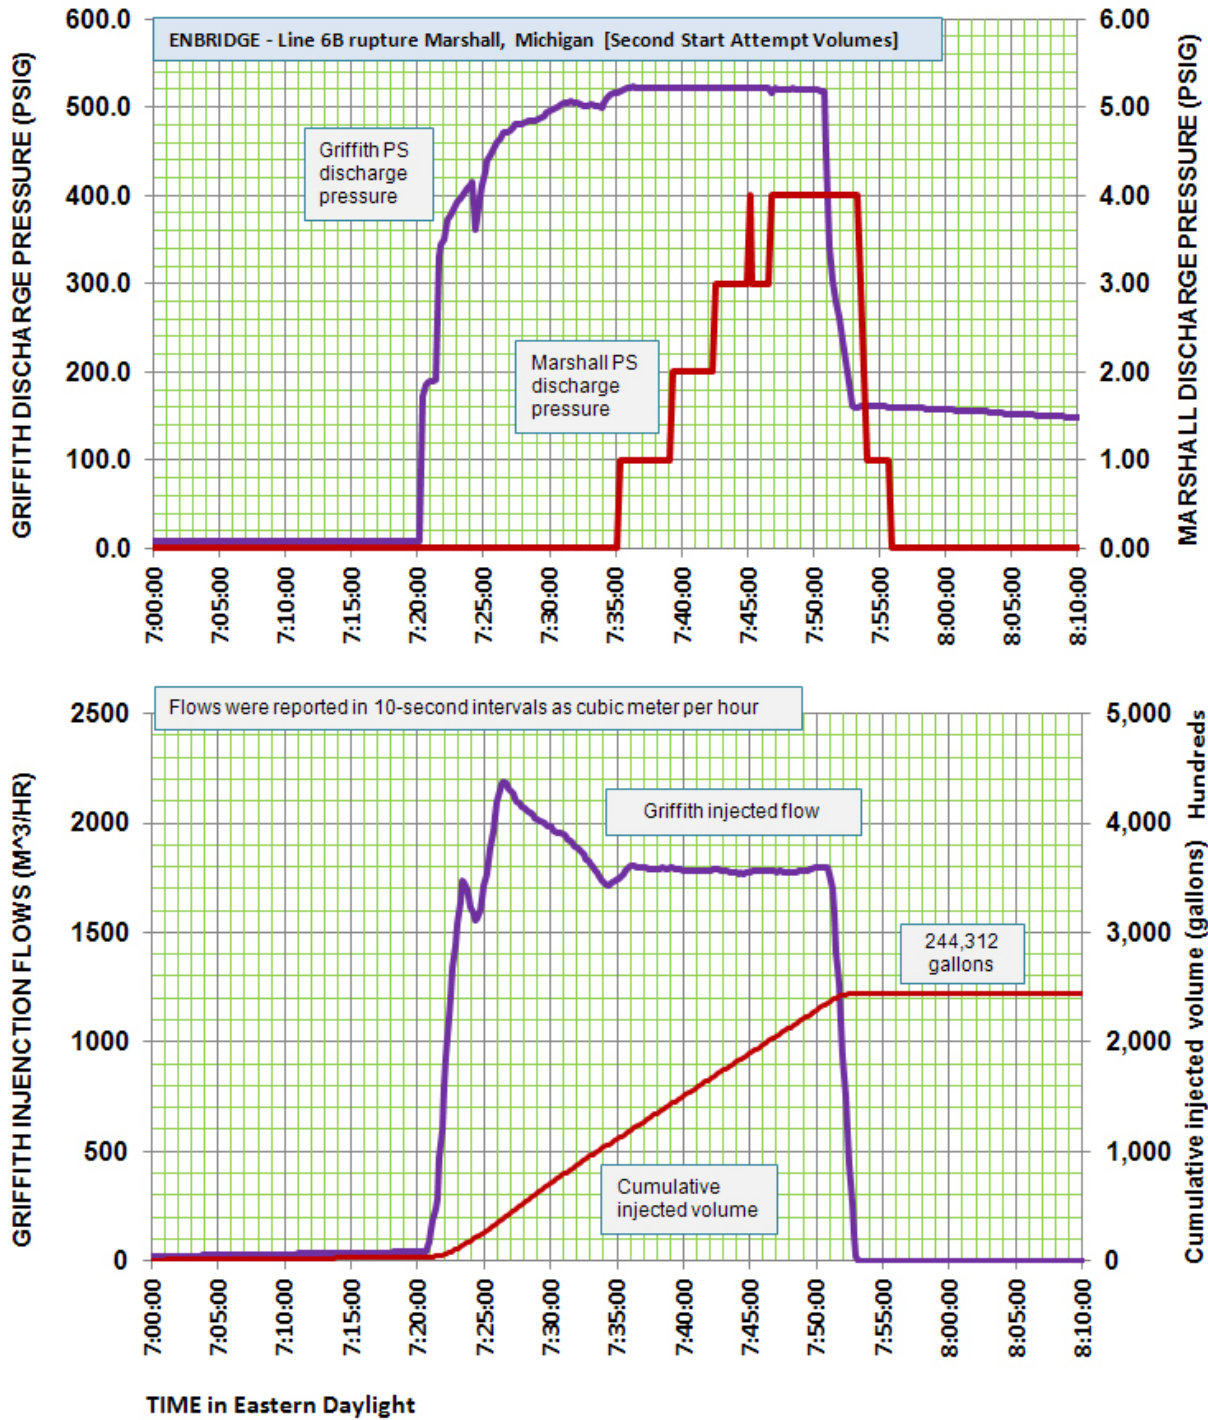
SCADA Pressure and Volumes Pumped—Startup Two

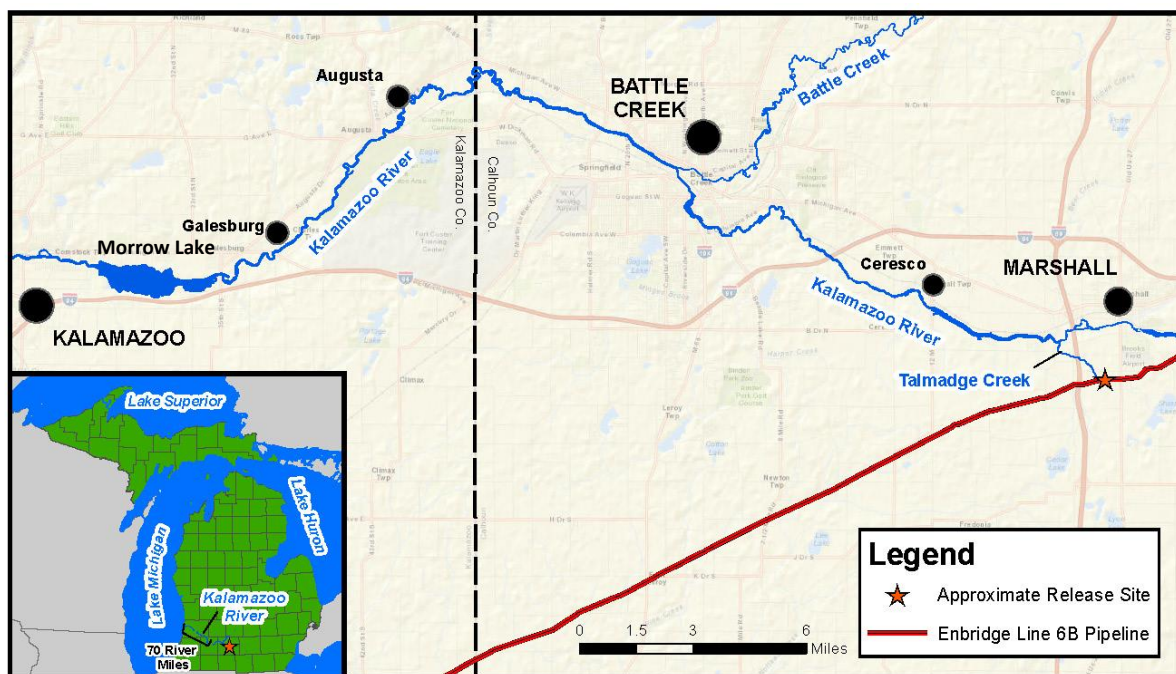
Figure 1. Location map of the approximately 38 miles of the Kalamazoo River and nearby towns affected by the 2010 Enbridge Line 6B oil spill near Marshall, MI. Morrow Lake is approximately 70 river miles upstream of Lake Michigan.

After Line 6B ruptured, oil spilled for over 17 hours during a product change from Western Canadian Select to Cold Lake Blend. Enbridge has reported that approximately 843,000 gallons of oil were discharged from the pipeline into the nearby Talmadge Creek and Kalamazoo River (Fig. 1). This discharge represents one of the largest inland oil spills into a freshwater system in North American history.

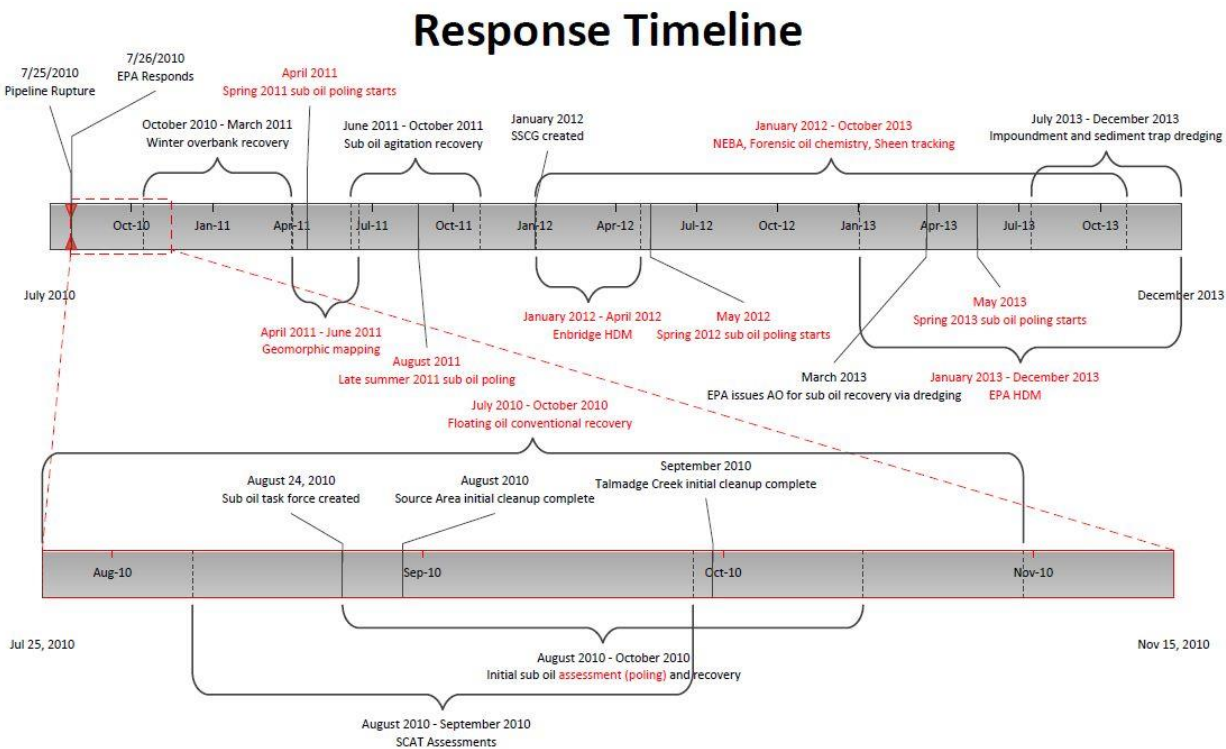
Figure 2. Response timeline for the Enbridge Line 6B oil spill. [SSCG, Scientific Support Coordination Group; NEBA, Net Environmental Benefit Analysis; SCAT, Shoreline Cleanup and Assessment Technique; HDM, Hydrodynamic modeling]

Personnel and contractors of the United States Environmental Protection Agency (U.S. EPA) responded to the Line 6B spill on July 26, 2010, the date that it was reported (Fig. 2). The U.S. EPA issued a Removal Administrative Order (Order) to Enbridge on July 27, 2010. The Order was issued pursuant to the authority vested in the President of the United States by Section 311(c) of the Federal Water Pollution Control Act §1321(c), as amended, and commonly known as the Clean Water Act (CWA). The amended CWA also includes the Oil Pollution Act of 1990, 33 U.S.C. §2701 et seq. The response efforts were managed utilizing the Incident Command System (ICS) under a Unified Command Structure with Incident Commanders from the U.S. EPA, Michigan Department of Environmental Quality (MDEQ), and Enbridge among others coordinating on response, assessment, and monitoring activities.

within the Kalamazoo River system. A Submerged Oil Task Force (SOTF) was created in late August 2010 to perform field assessments, characterization, and mapping of submerged oil (Fig. 2). Enbridge was directed to begin installing submerged oil containment structures at numerous locations within the Kalamazoo River. These structures included gabion baskets filled with absorbent snare booms installed on the bottom of the river and silt curtains extending from the river bed to the water's surface. In addition, a sediment basin was constructed within Talmadge Creek to enhance sediment and submerged oil deposition upstream of its confluence with the Kalamazoo River.

By 2011, submerged oil had proved much more challenging to recover than floating and overbank oils and increasingly became the focus of cleanup efforts (Fig. 2) (U.S. Environmental Protection Agency, 2011). It was clear that there was no single technology that would be operationally effective. During the summer of 2011, submerged oil recovery efforts focused on various manual and mechanical sediment agitation techniques to liberate the oil from the sediment, followed by conventional recovery of the oil from the water surface. Although these techniques were successful in recovering Line 6B oil, the results of the Late Summer 2011 Reassessment poling led the U.S. EPA to question the continued use of agitation as a recovery tool. The Federal On-Scene Coordinators (FOSCs) tasked U.S. EPA's Scientific Support Coordinators (SSCs) and a Scientific Support Coordination Group (SSCG) led by the SSCs to devise a multiple-lines-of-evidence strategy to inform submerged oil characterization, recovery strategies and endpoint determinations. Some of the components of this strategy were developed by operations and situation personnel (geomorphological mapping, poling assessments, and sheen tracking) and some were driven by scientific support staff (hydrodynamic and sediment transport modeling, forensic oil chemistry, and Net Environmental Benefit Analysis (NEBA)).

Poling reassessments were again conducted in spring 2012, late summer 2012, and spring 2013 (Fig. 2). These reassessments were all conducted above the minimum water and sediment temperature threshold of 60° F. Poling data from these reassessment activities have been valuable in tracking and mapping the submerged oil footprint over time, and have assisted

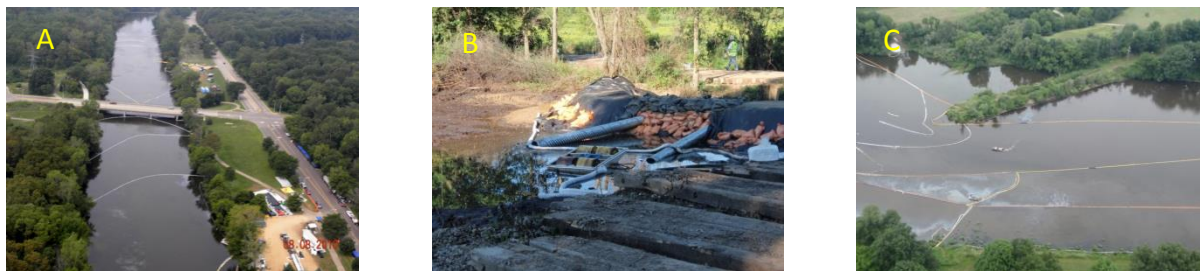
Figure 3. Oil collected over time with different methods: A, conventional floating absorbent boom; B, inverted weir dam in Talmadge Creek; and C, new agitation toolbox technique (photos by Weston/START).

Because much of the oil remained floating in the days immediately following the release, conventional methods and equipment were effective in containment and recovery of this floating component. Over 12,000 linear feet of conventional surface containment boom and over 8,000 feet of absorbent boom were deployed to contain and aid recovery of the floating oil within the first week following the release (Fig. 3A). During this time, however it became apparent that these would not work for the sinking component, leading to application of alternative tactics like agitation (Fig. 3C).

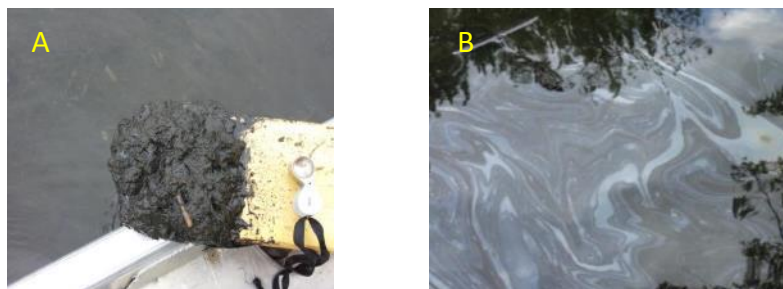
Figure 4. Photos from the Kalamazoo River: (A) Oiled soft sediment in the vicinity of the Ceresco impoundment in 2012 and (B) typical oil sheen and globs on the water surface near soft sediment deposits in the Battle Creek millponds in 2013.

indications were that it accumulated in depositional areas of the river and had an affinity for aggregation with fine-grained soft sediment (silt, clay and organic matter accumulations with high water content) (Fig. 4). Slow-moving areas with submerged oil included reaches where the slope of the river flattened, such as at the three impoundments, or where the river widened enough to allow for depositional areas along channel margins. Submerged oil also was associated with secondary channels, oxbows, the downstream side of islands, and tributary mouths.

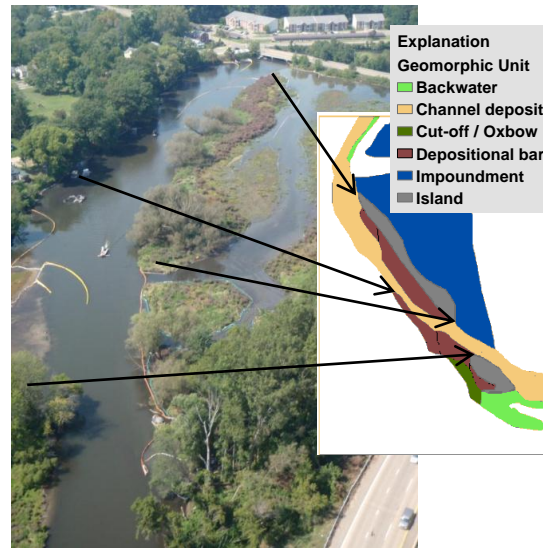
Figure 5. Mapping the locations of depositional geomorphic settings helped guide submerged oil recovery efforts (photo Weston/START).

In spring 2011, delineation of geomorphic surface units (GSUs) for the oil-affected reach of the Kalamazoo River was done in a Geographic Information System (GIS) based on the synthesis of multiple data sources (Enbridge Energy, L.P., 2012a) (Fig. 5). Channel longitudinal profile and slope data were collected in the summer and fall 2010 (Tetra Tech, Inc., 2011). Fluvial landforms, anthropogenic features, bank lines, and channel widths were interpreted from April 2011 leaf-off aerial photographs. Particle size of river sediment was visually assessed during the Spring 2011 Reassessment poling and core collection and logging and was grouped into eight categories – gravel and larger, sand and gravel, sand, sand and silt, sand over silt, silt over sand, soft sediment, and organic. Water depths from the Spring 2011 Reassessment poling were used as a final refinement of the GSUs. The resultant 28 geomorphology-based categories were used to delineate areas of the river channel that were prone to either erosion or deposition. This technique of mapping river geomorphic settings and looking for submerged oil in depositional areas became an important tool to locate remaining problem areas after the floating oil was removed.

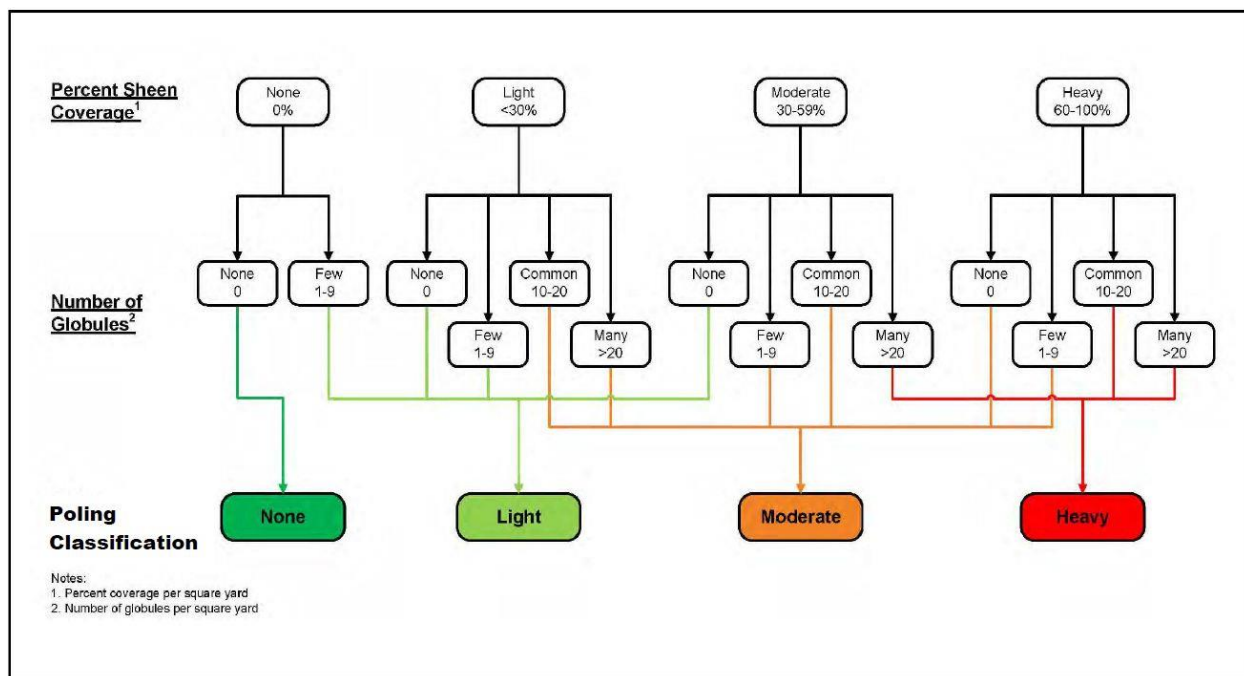
Figure 6. Flowchart used for field observations of submerged oil during poling assessments.

Sediment poling became a primary submerged oil assessment tool. The sediment was agitated using a graduated aluminum pole with an 8-inch diameter metal disc on the submerged end. If submerged oil was present in the sediment, the agitation action liberated oil from the sediment, allowing it to float to the water surface. The percent coverage of oil sheen and number of globs at the water's surface within one square yard were observed and categorized as 'none', 'light', 'moderate', or 'heavy' according to the Field Observation Submerged Oil Flowchart (Fig. 6).
