**RE: Hearing Order OH-001-2014**  
**Trans Mountain Pipeline ULC (Trans Mountain)**  
**Application for the Trans Mountain Expansion Project (Project)**  
**Elizabeth May Written Evidence**

# The Behaviour and Environmental Impacts of Crude Oil Released into Aqueous Environments

**Meeting of the Royal Society of Canada's Expert Panel on  
*The Behaviour and Environmental Impacts of Crude Oil Released into Aqueous Environments*  
Wednesday, February 4, 2015**

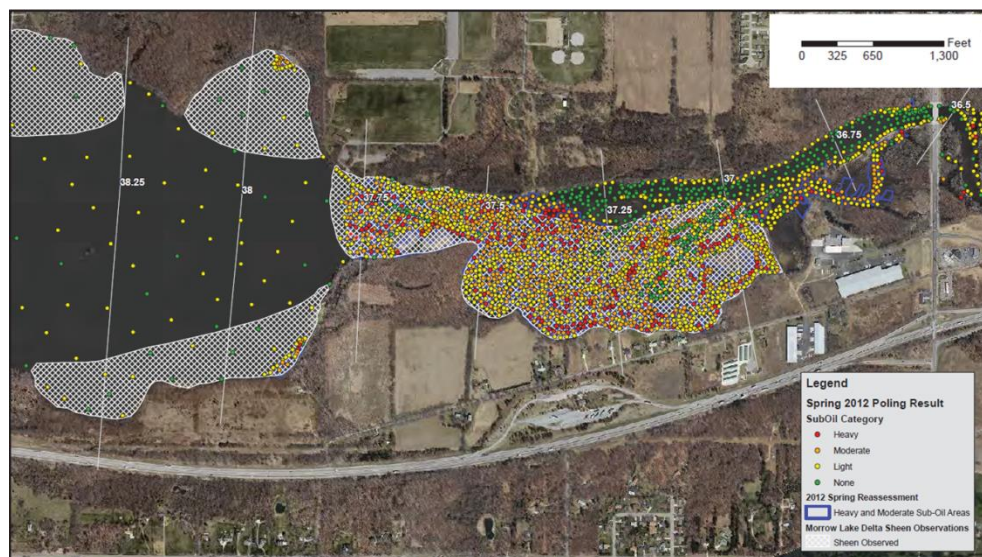
Figure 7. Sheen management areas overlain with Fall 2012 Reassessment poling data in Morrow Lake delta.

When sheen location data were mapped, it became readily apparent that there was visual correlation among problematic sheening locations, depositional geomorphic settings, and heavy/moderate poling results (Fig. 7). These three independent lines of evidence converged on a picture of submerged oil being associated with deposits of fine-grained or soft organic-rich sediment. In addition, forensic oil chemistry results confirmed that Line 6B oil was the source of the vast majority of surface expressions of oil globs and sheen in the river (greater than 95% of sheen samples collected were confirmed as derived from Line 6B oil, see Forensic Oil Chemistry section below).

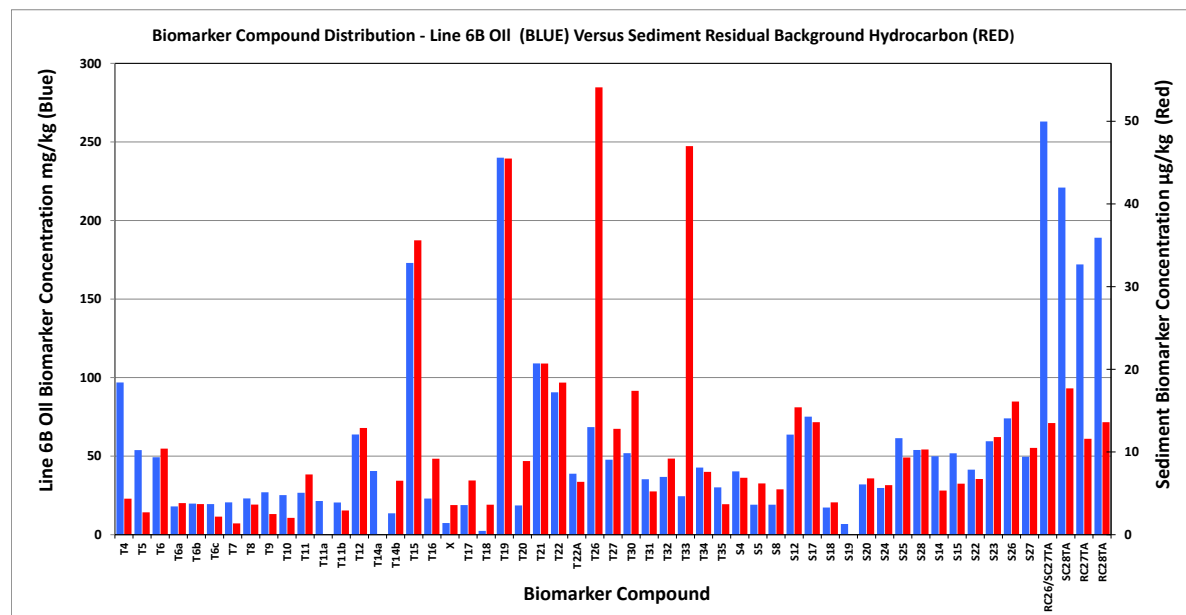
Figure 8. Example biomarker plot of Line 6B oil versus residual background hydrocarbons (RBH) present in Kalamazoo River sediment. The four triaromatic stearene biomarkers shown at the far right end of the plot are enriched in Line 6B oil. Samples were normalized to hopane levels (T19). Concentrations of hydrocarbons T26 and T33 are elevated in the sediment compared to Line 6B oil because of background levels of peat-related compounds often found in river sediment (Courtesy G. Douglas, NewFields, written commun., 2014).

After the Line 6B oil submerged and became distributed throughout the river system, it became apparent that forensic oil chemistry methods would be needed to determine whether it was possible to distinguish Line 6B oil from other residual background hydrocarbons (RBHs) that might be present in the Kalamazoo River sediments. Nearby urban areas likely contributed RBHs from nonpoint sources as well as occasional dumping and small spills. The objective of the work was to determine whether it would be possible to identify Line 6B oil in environmental samples with a high degree of certainty because of high background levels of other sources of oil contaminants. Based on this work, it was shown that Line 6B oil was enriched in certain triaromatic stearene biomarkers (Fig. 8), that could be used to differentiate the spilled oil from background oil sources (G. Douglas, in prep). These results were used to demonstrate definitively whether sheen/globule samples contained Line 6B oil. Environmental samples that contained Kalamazoo River sediment were more challenging to evaluate. Nevertheless, methods were developed to identify Line 6B oil in sediment samples that contained varying levels of RBH (G. Douglas, NewFields, written commun., 2014).
